FINAL REPORT

South Scappoose Creek Restoration Plan

prepared for Scappoose Bay Watershed Council

MARCH 2009

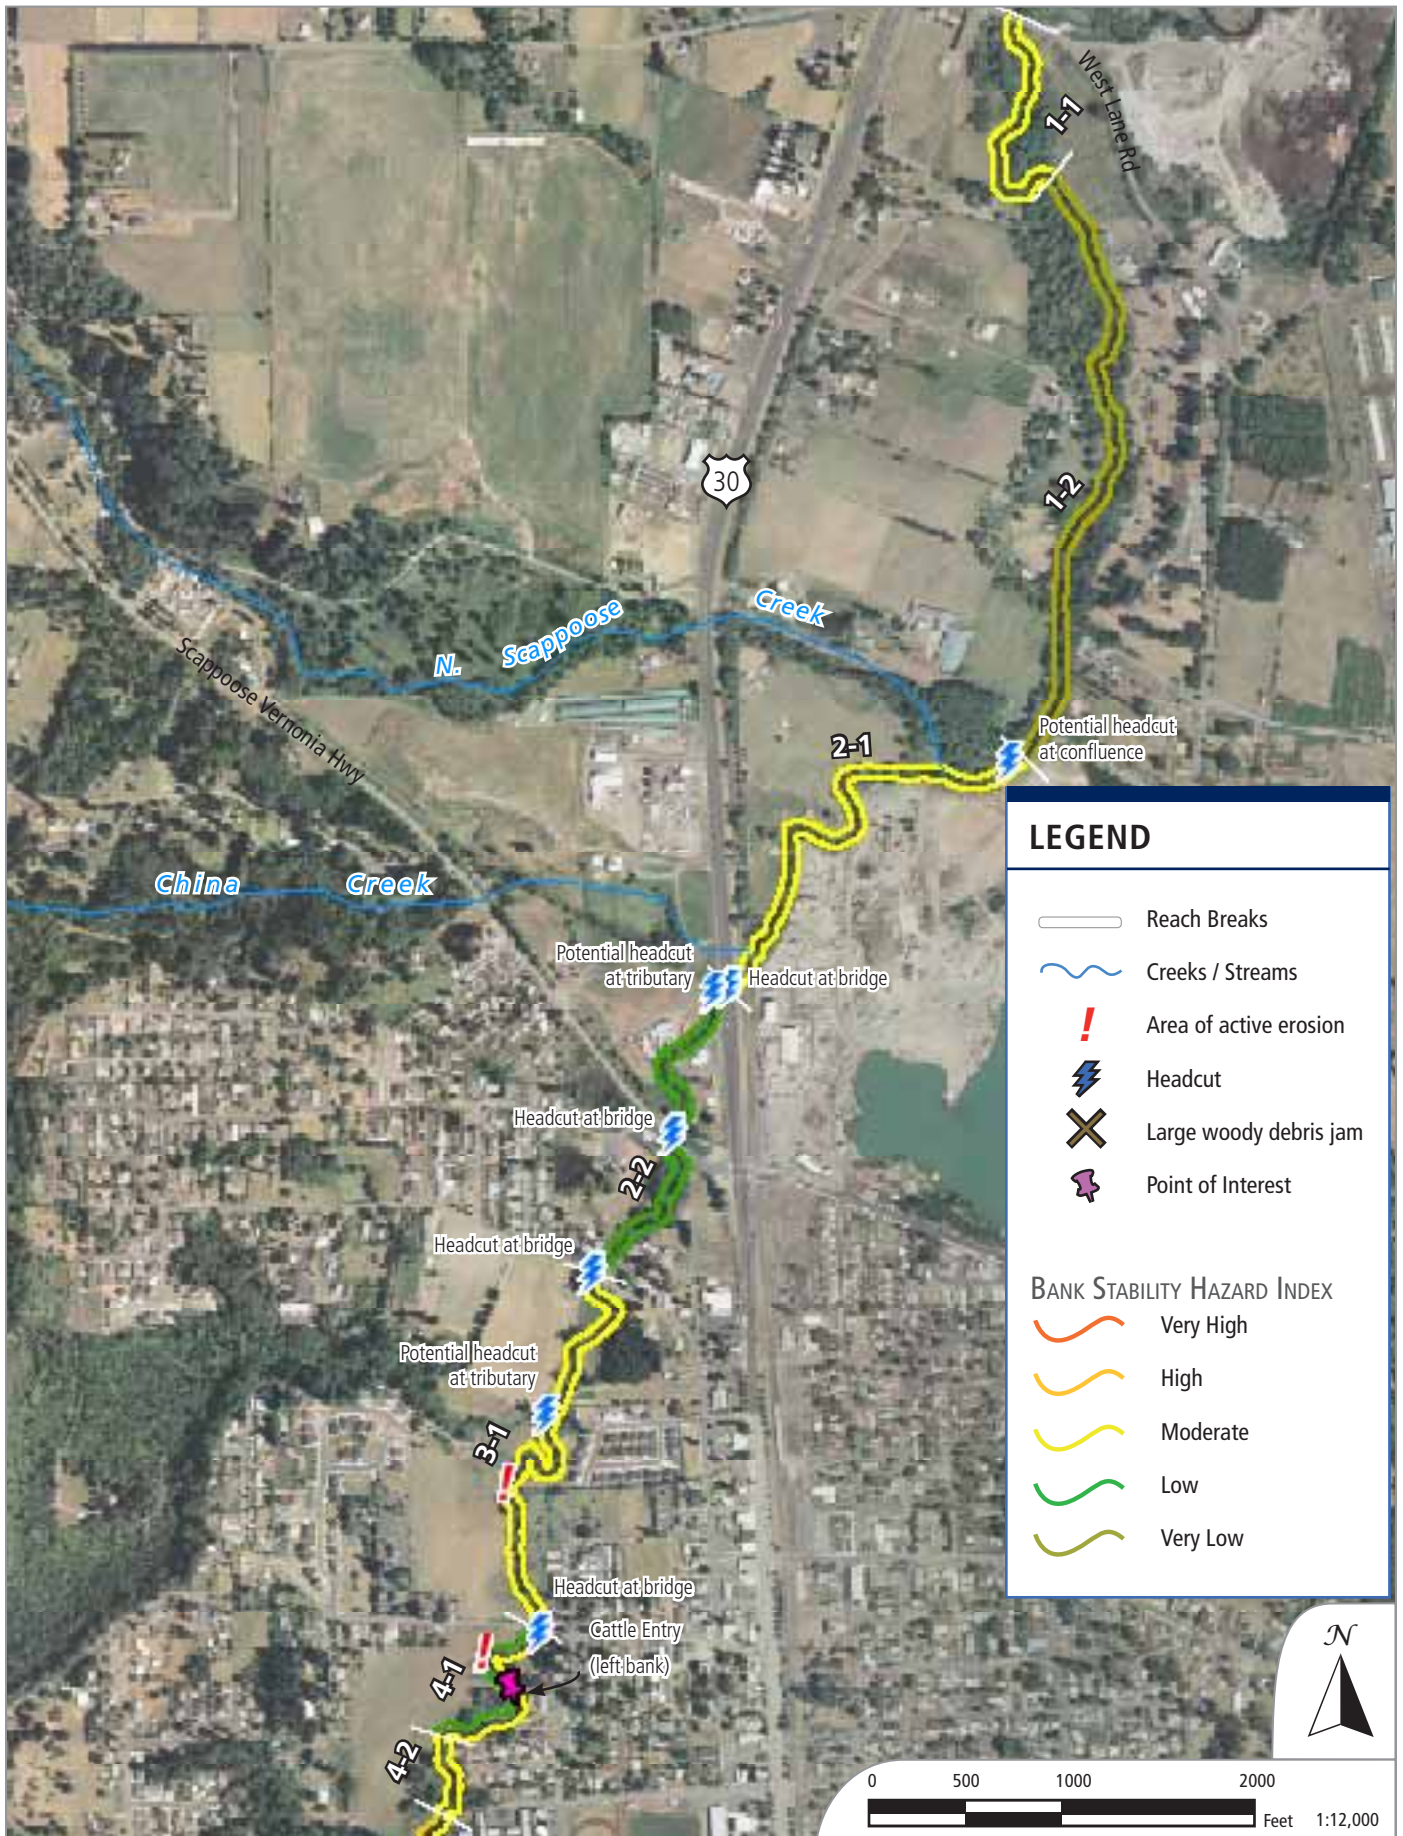
ES-3: A bank and channel stability survey was conducted on South Scappoose Creek through the project area. The selected study approach, based on Rosgen (1996), produced a Bank Erosion Hazard Index (BEHI) for each bank along with site specific bank and bed stability observations.

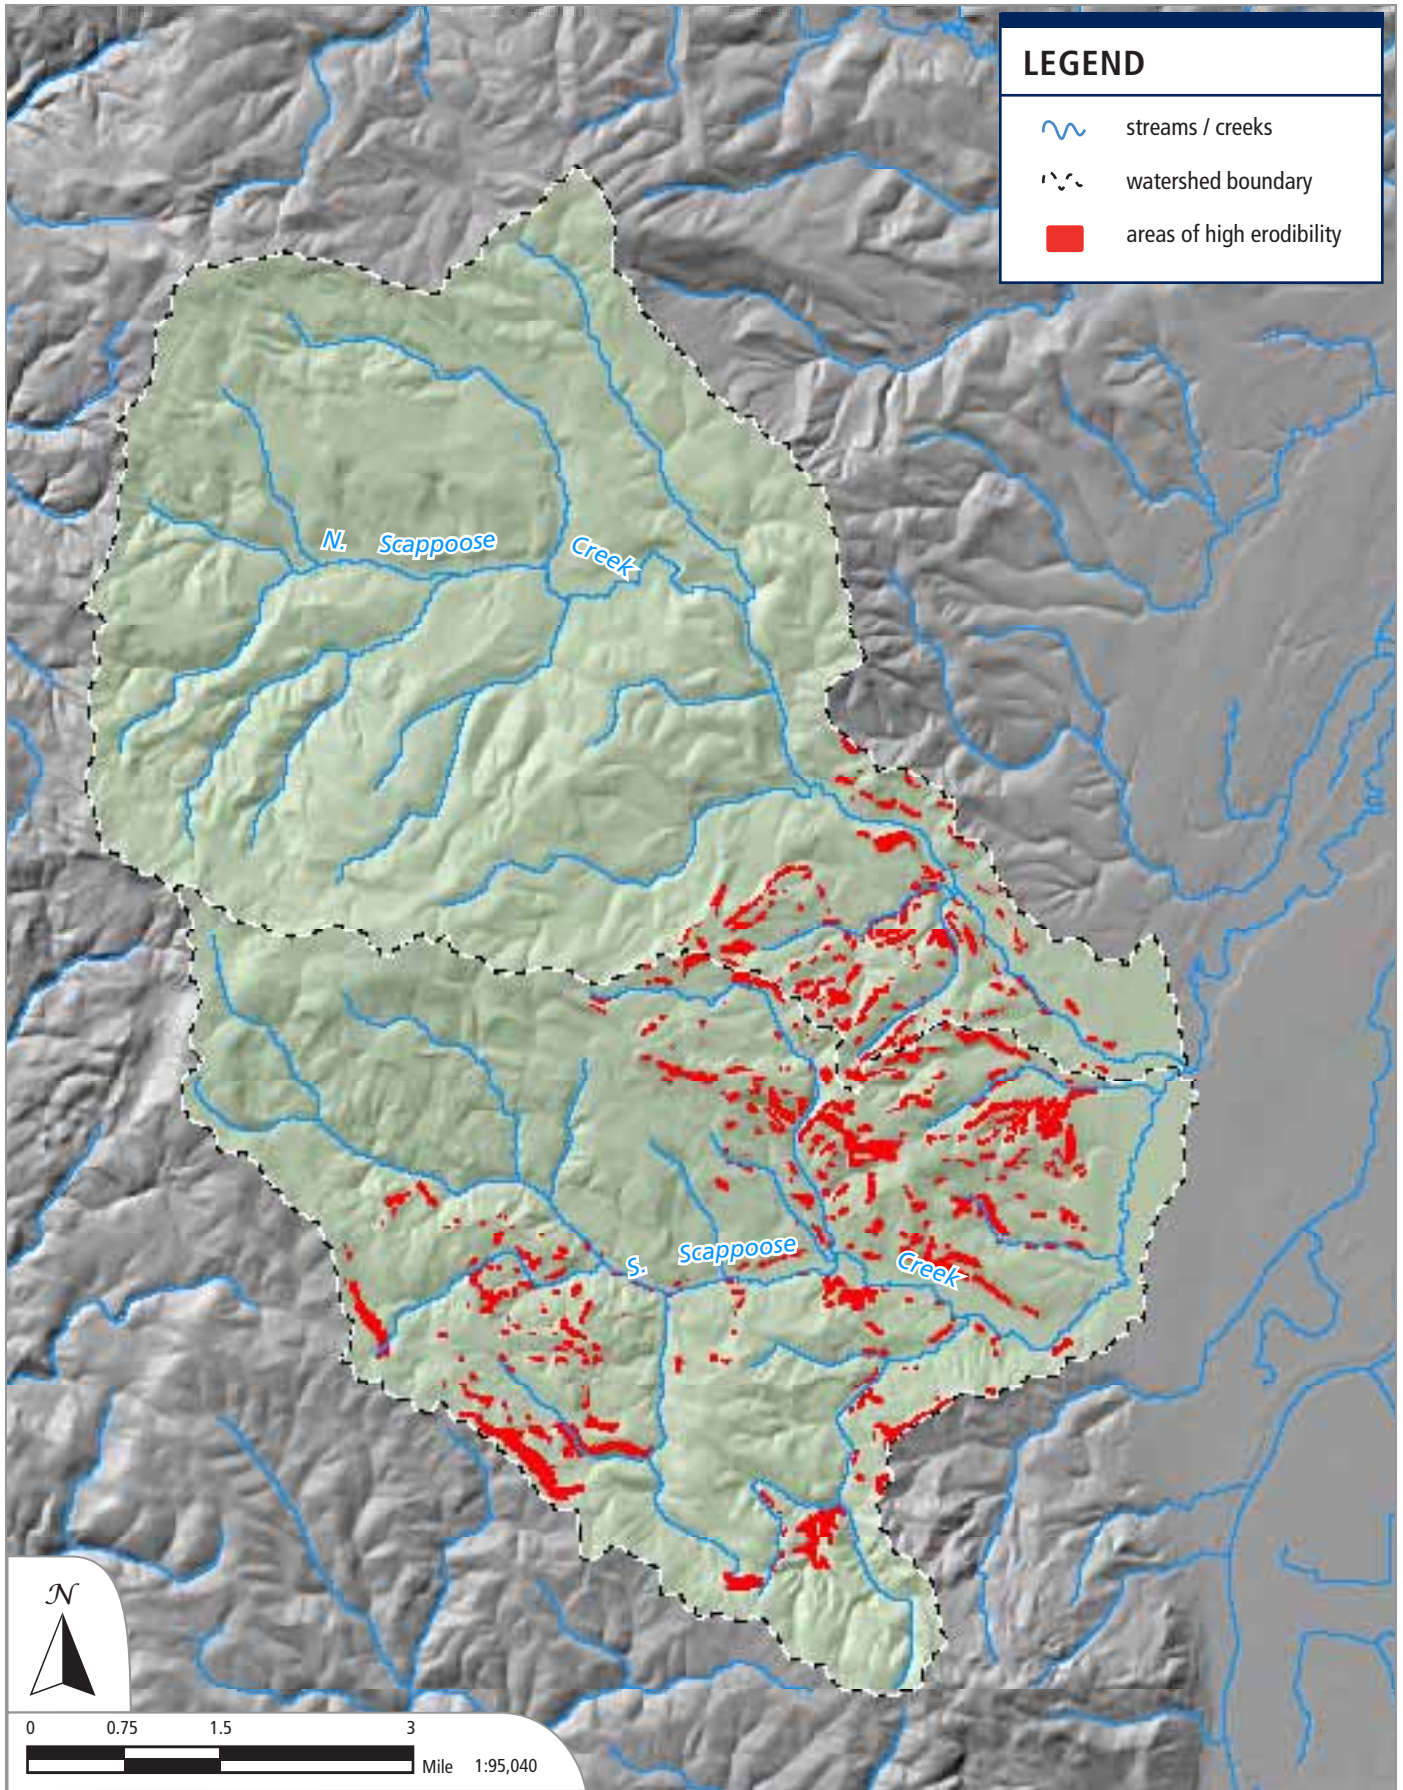
FIGURE 6: Map depicting areas classified as a high risk of erosion associated with landslides and debris flows. The criteria used to depict high erosion risk are slopes greater than 30% and soils with a k-factor of erodibility classified as High (k-factor > 0.25).

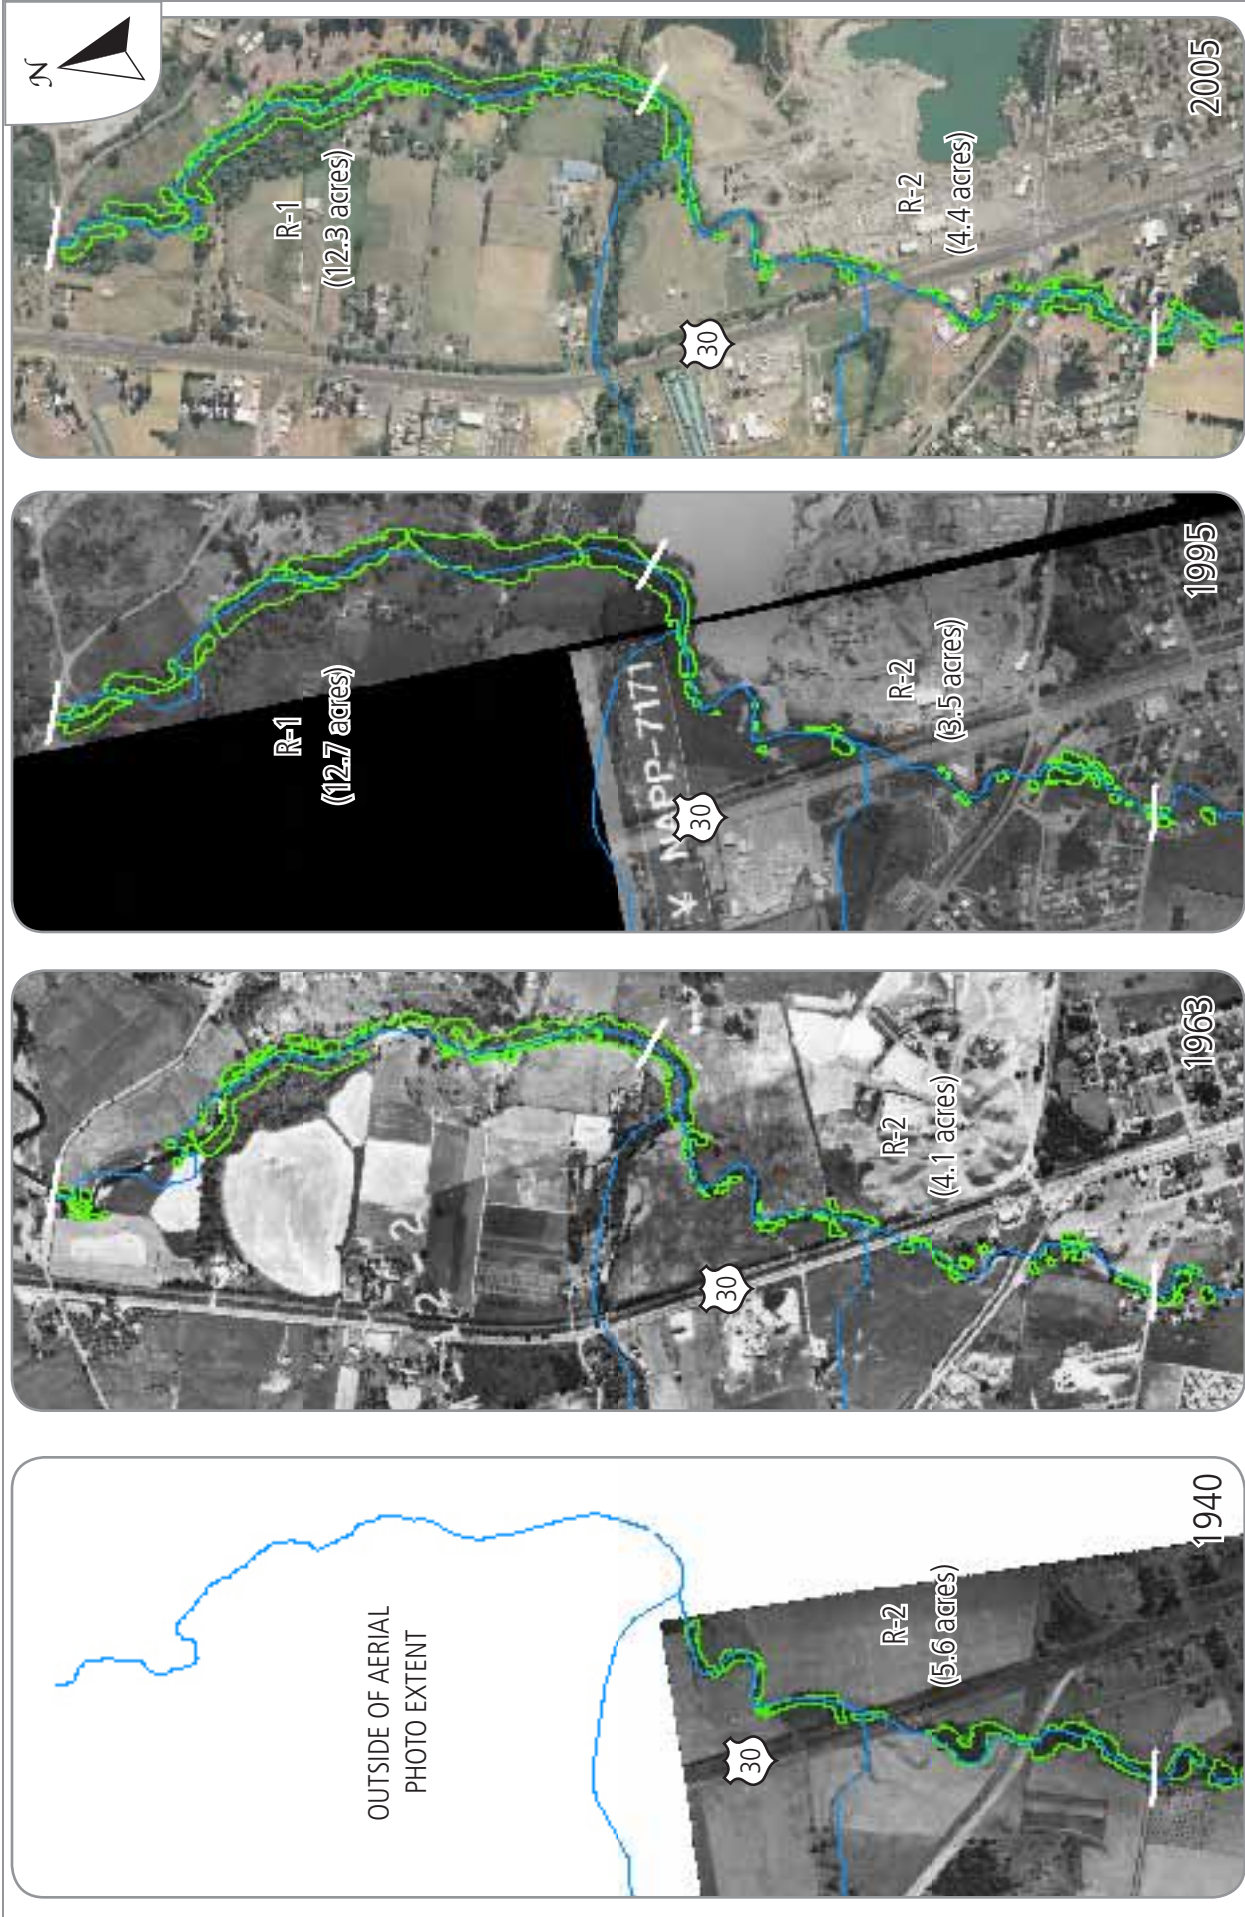
FIGURE 9: Extent of riparian vegetation mapped from aerial photos for the project area from 1940, 1963, 1995, and 2005. Riparian vegetation was mapped if it occurred within 100 feet of the channel. Generally, results indicate an increase in riparian vegetation since 1940, most likely due to conversion from farm or grazing land uses to residential or rural residential.

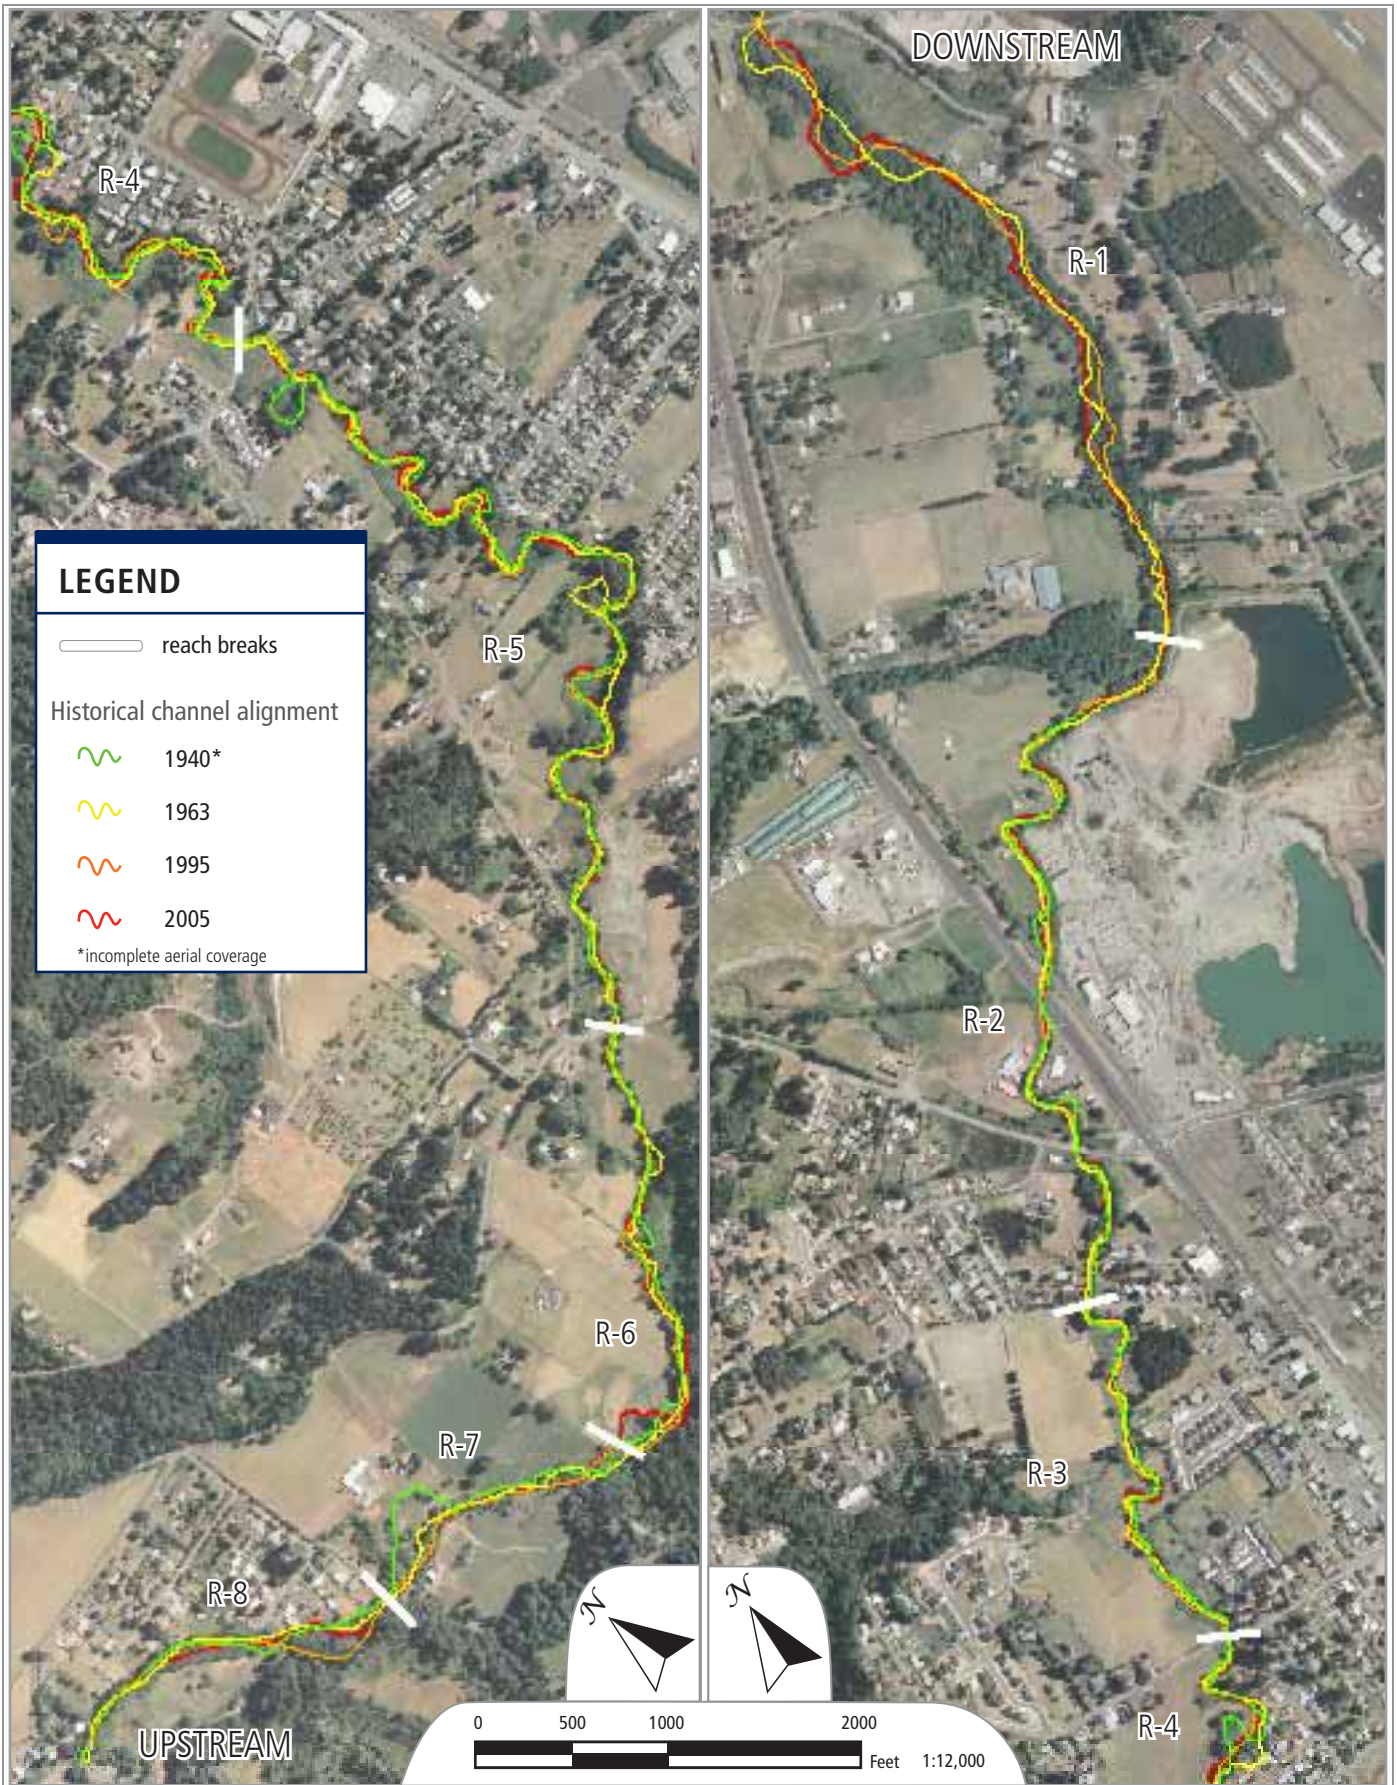
FIGURE 10: Mapped channel planform from aerial photos of the project area for 1940, 1963, 1995, and 2005. Localized changes in the location of the primary channel were observed over the 65 year study period. The data was also used to evaluate reach-scale changes in sinuosity.

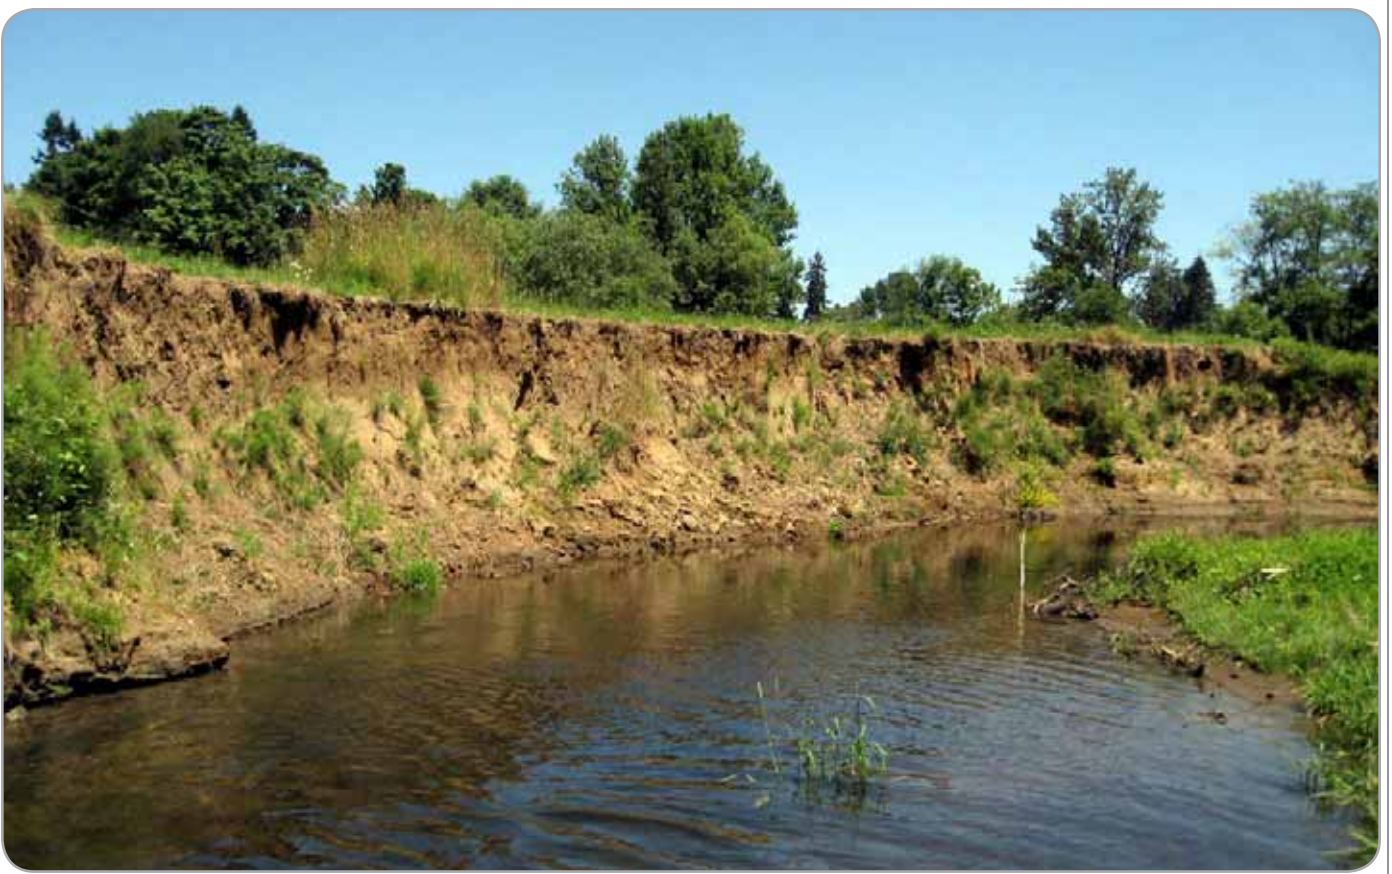
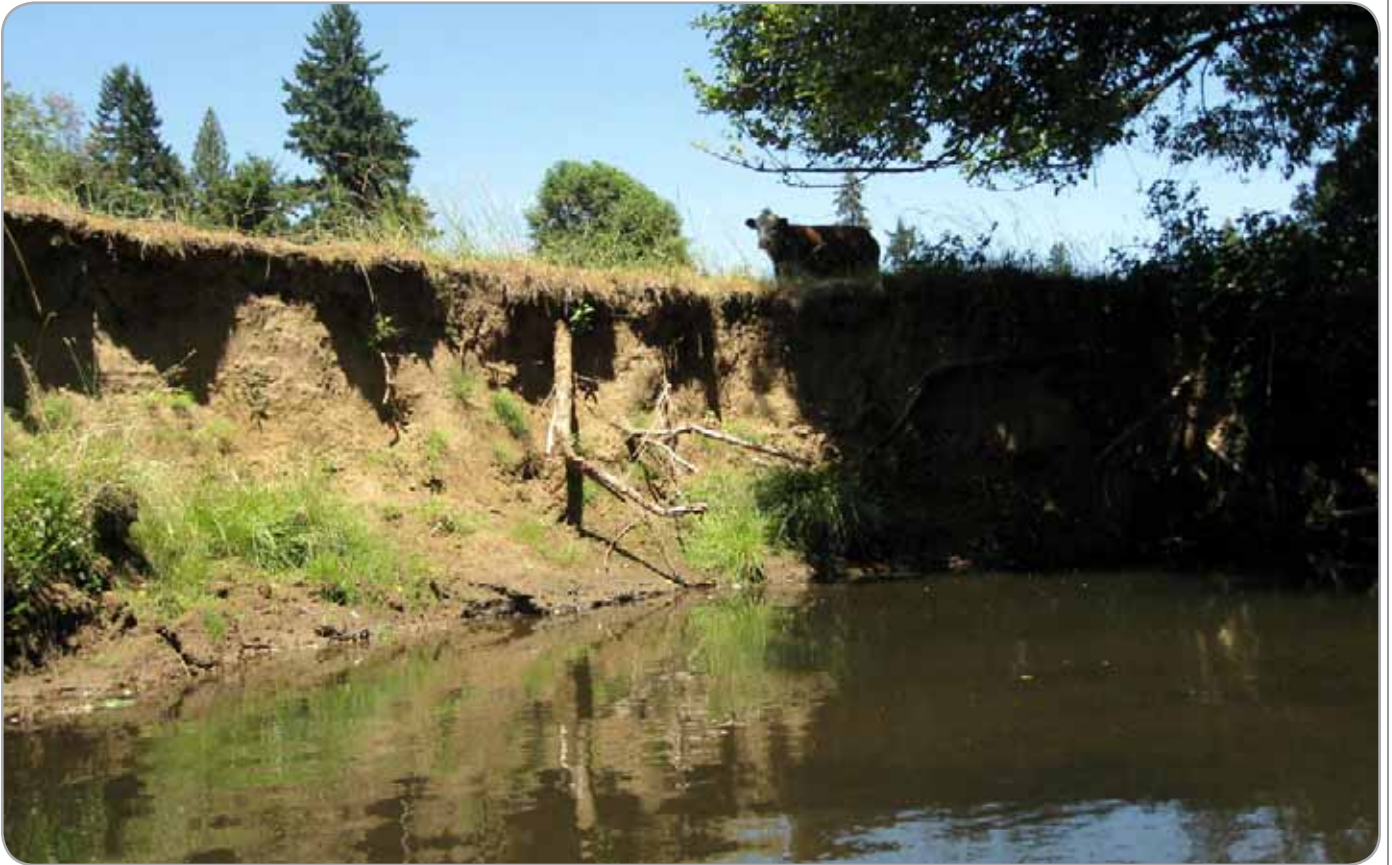
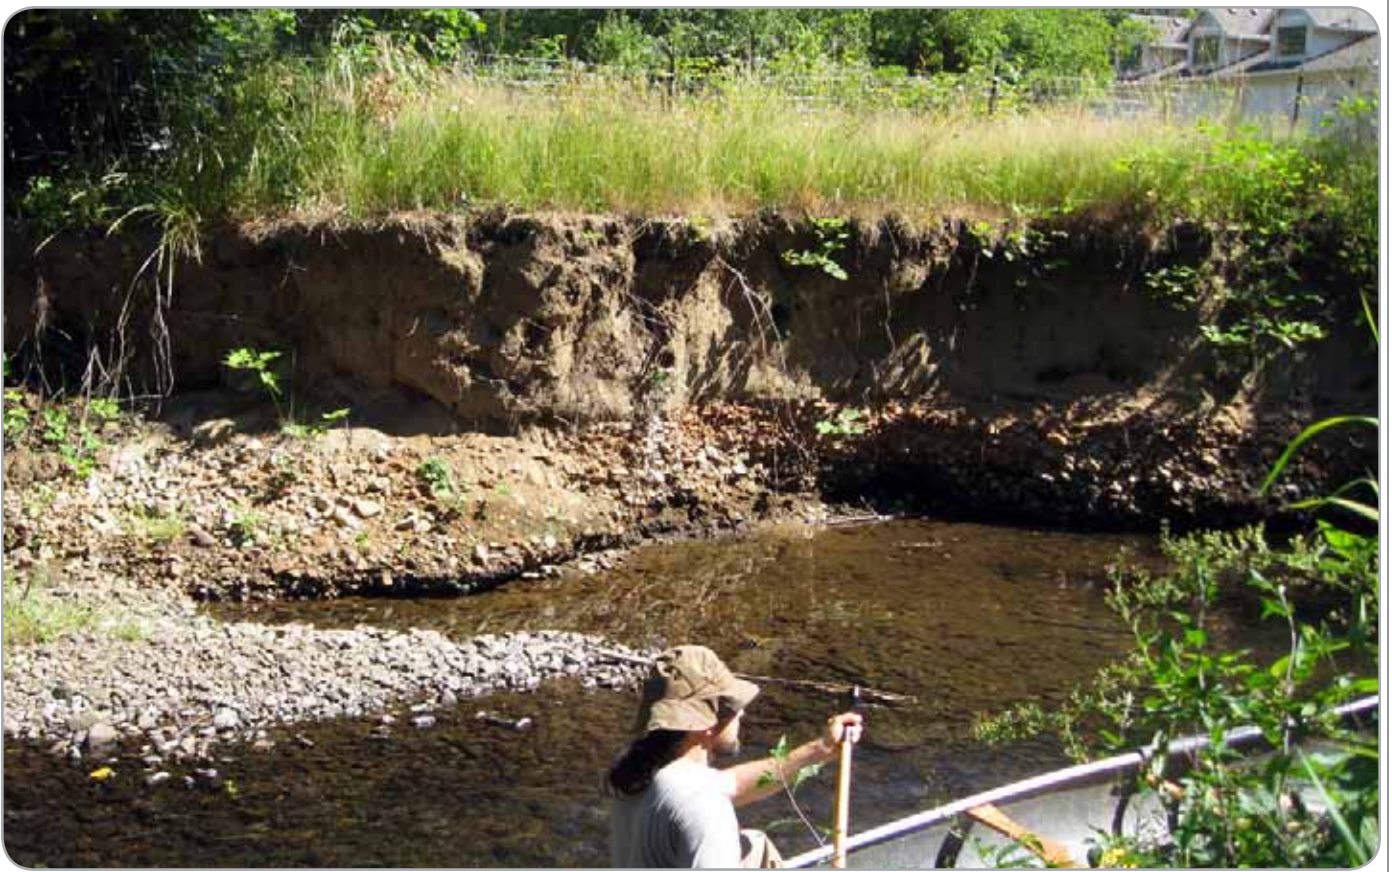
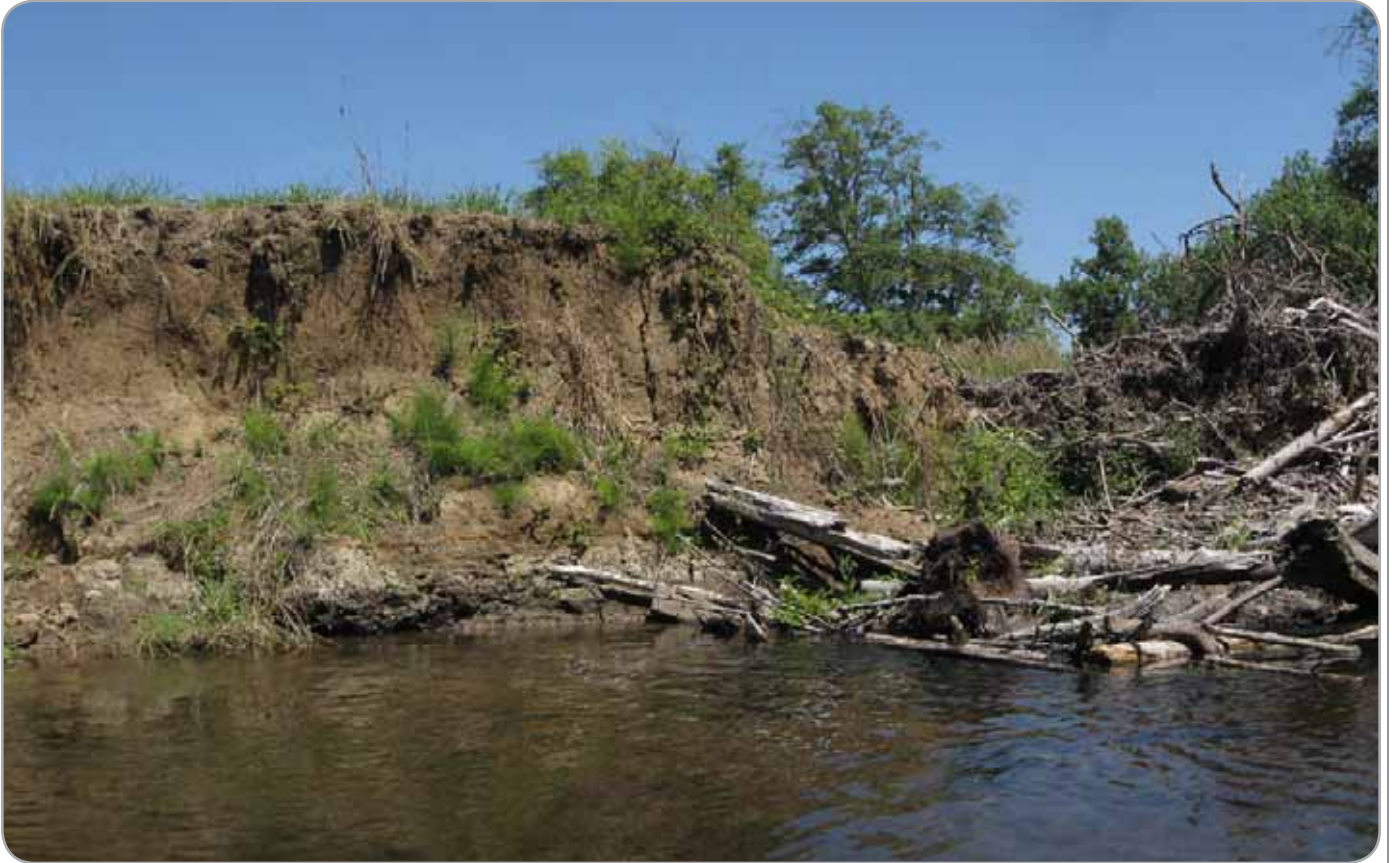
FIGURE 13: Examples of active bank erosion along South Scappoose Creek. Areas with the most significant bank erosion occur between Dutch Canyon Road and the Columbia Highway crossing. Note the clumps of grass at the toe of slope in several of the photos, indicating that the primary mechanism of erosion is block failure.

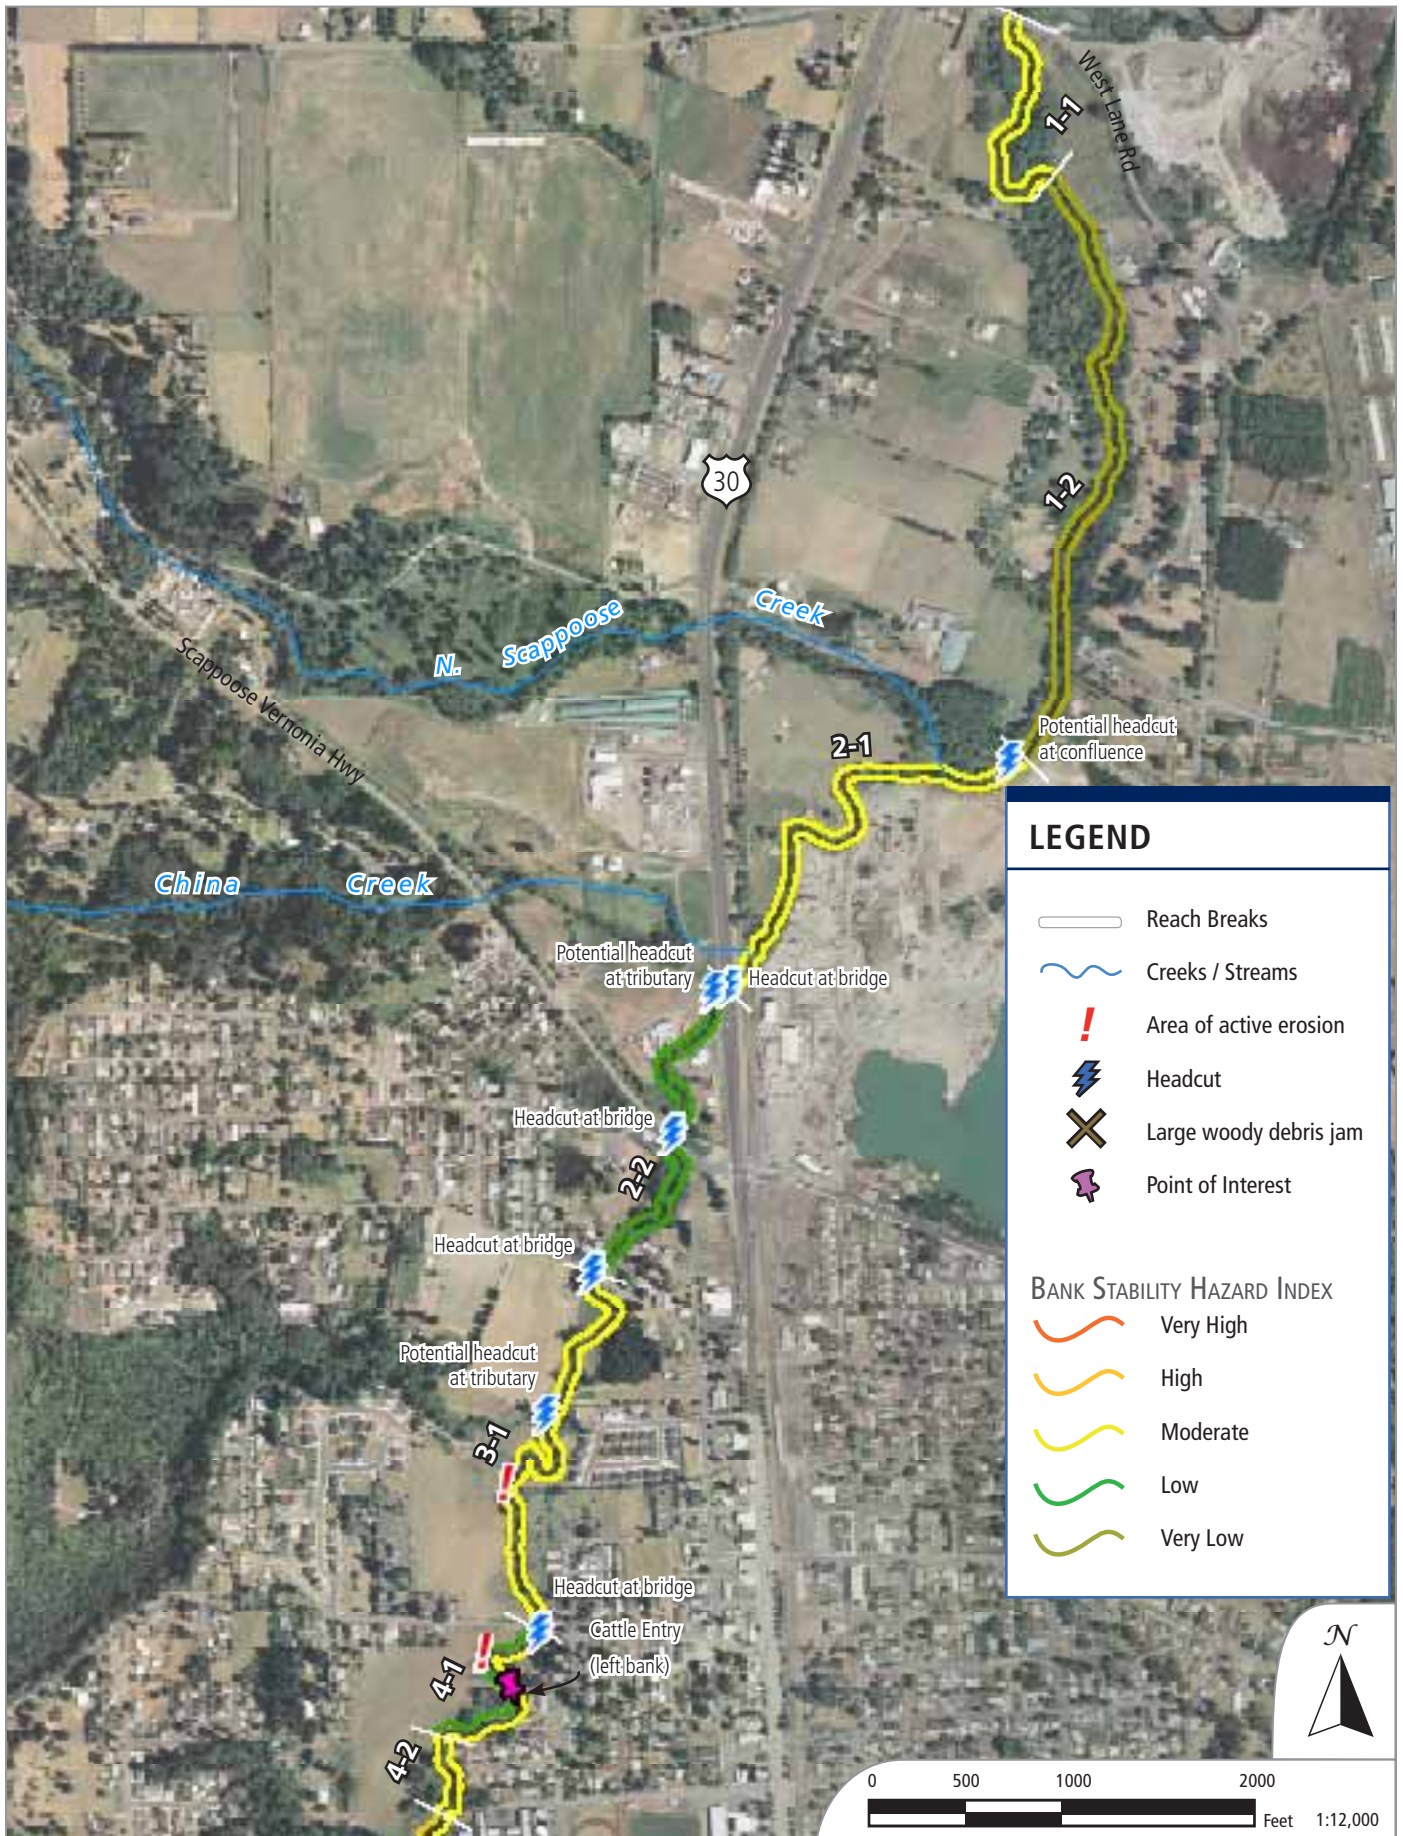
FIGURE 16: A bank and channel stability survey was conducted on South Scappoose Creek through the project area. The selected study approach, based on Rosgen (1996), produced a Bank Erosion Hazard Index (BEHI) for each bank along with site specific bank and bed stability observations. 39

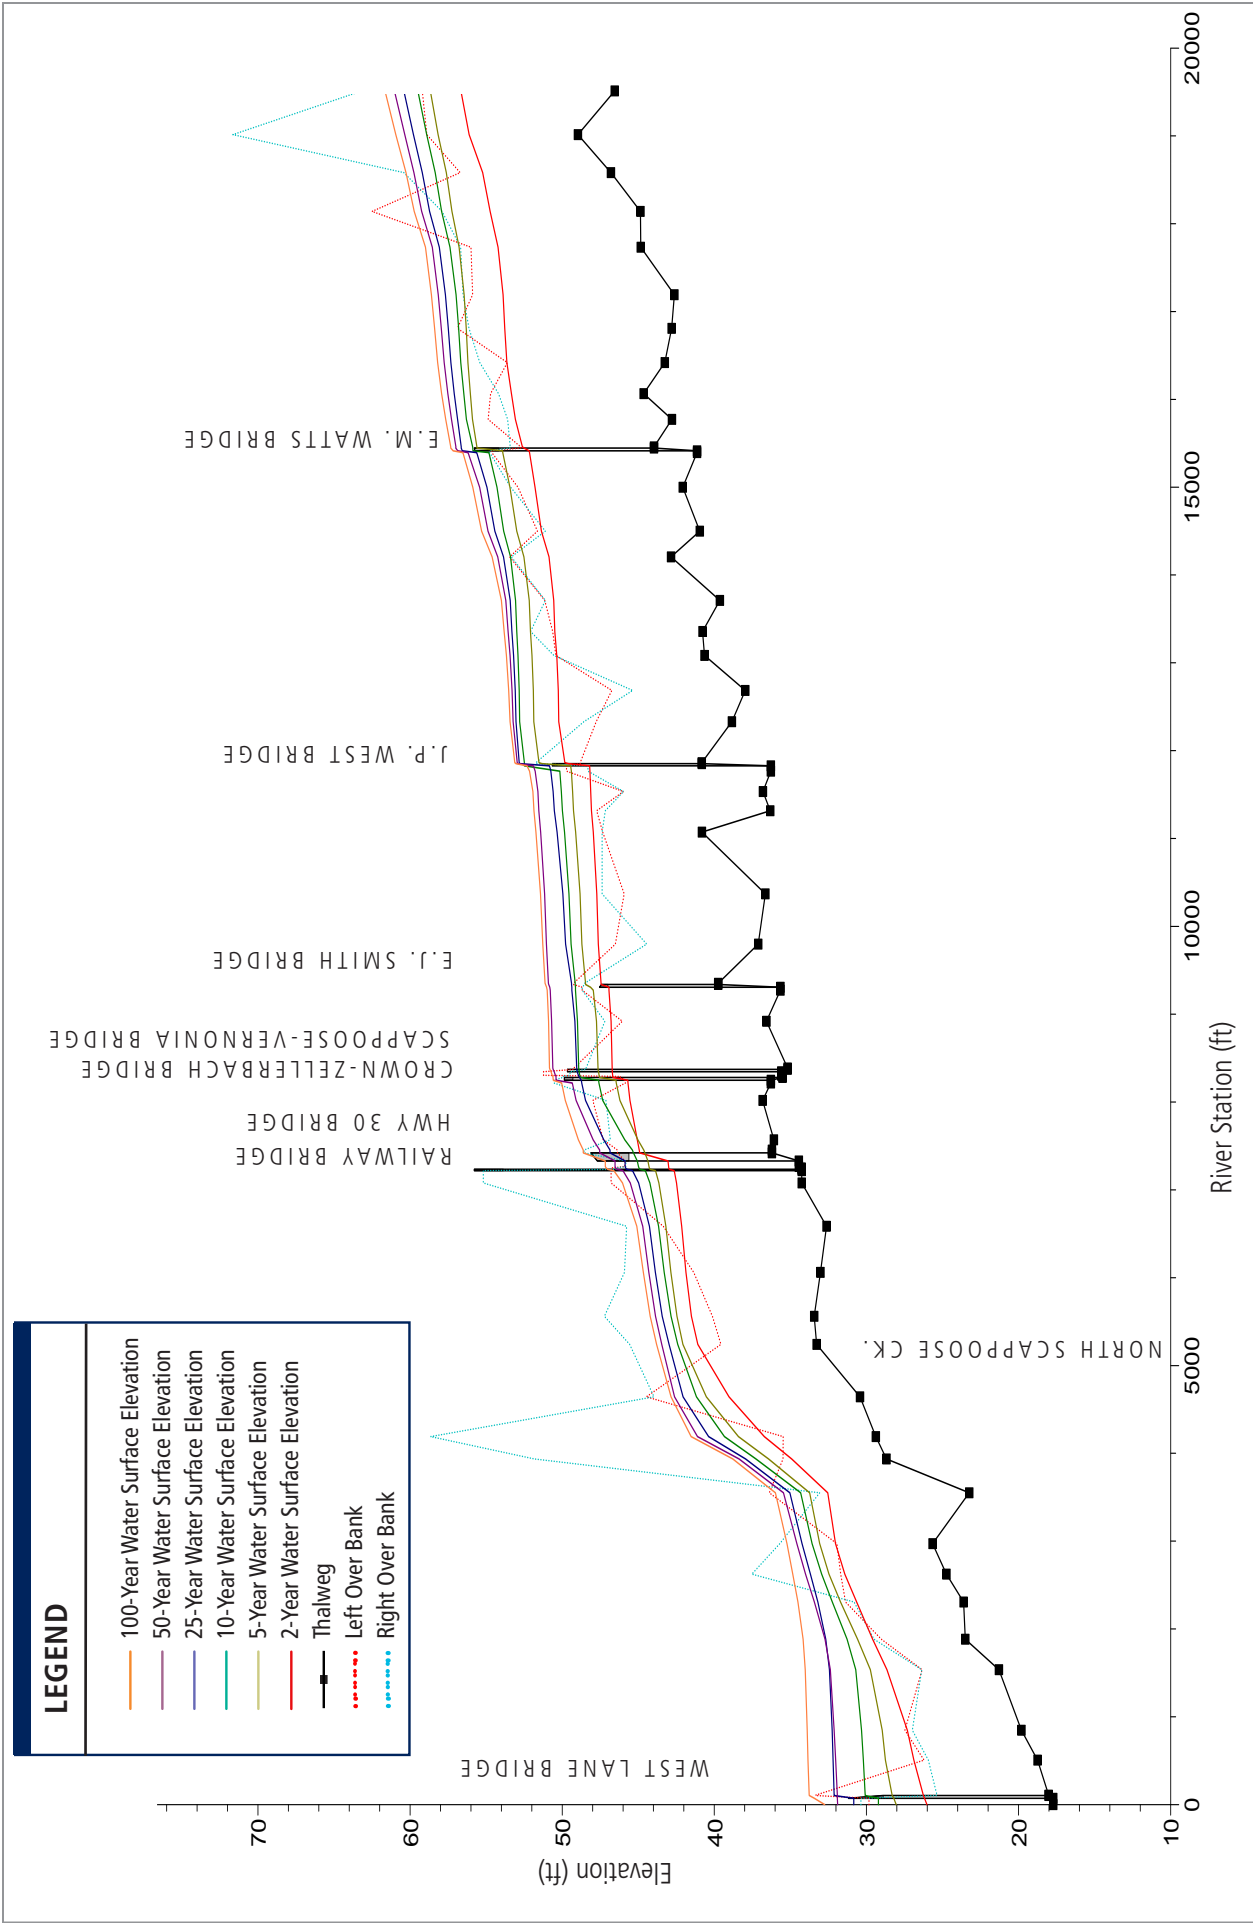
FIGURE 17: Modeled peak discharge water surface profiles for South Scappoose Creek for the portion of the project area covered by the LIDAR data. Note the backwatering that occurs upstream of the bridges during most modeled flows. Most of the bridges are overtopped in the 50 and 100-year events.

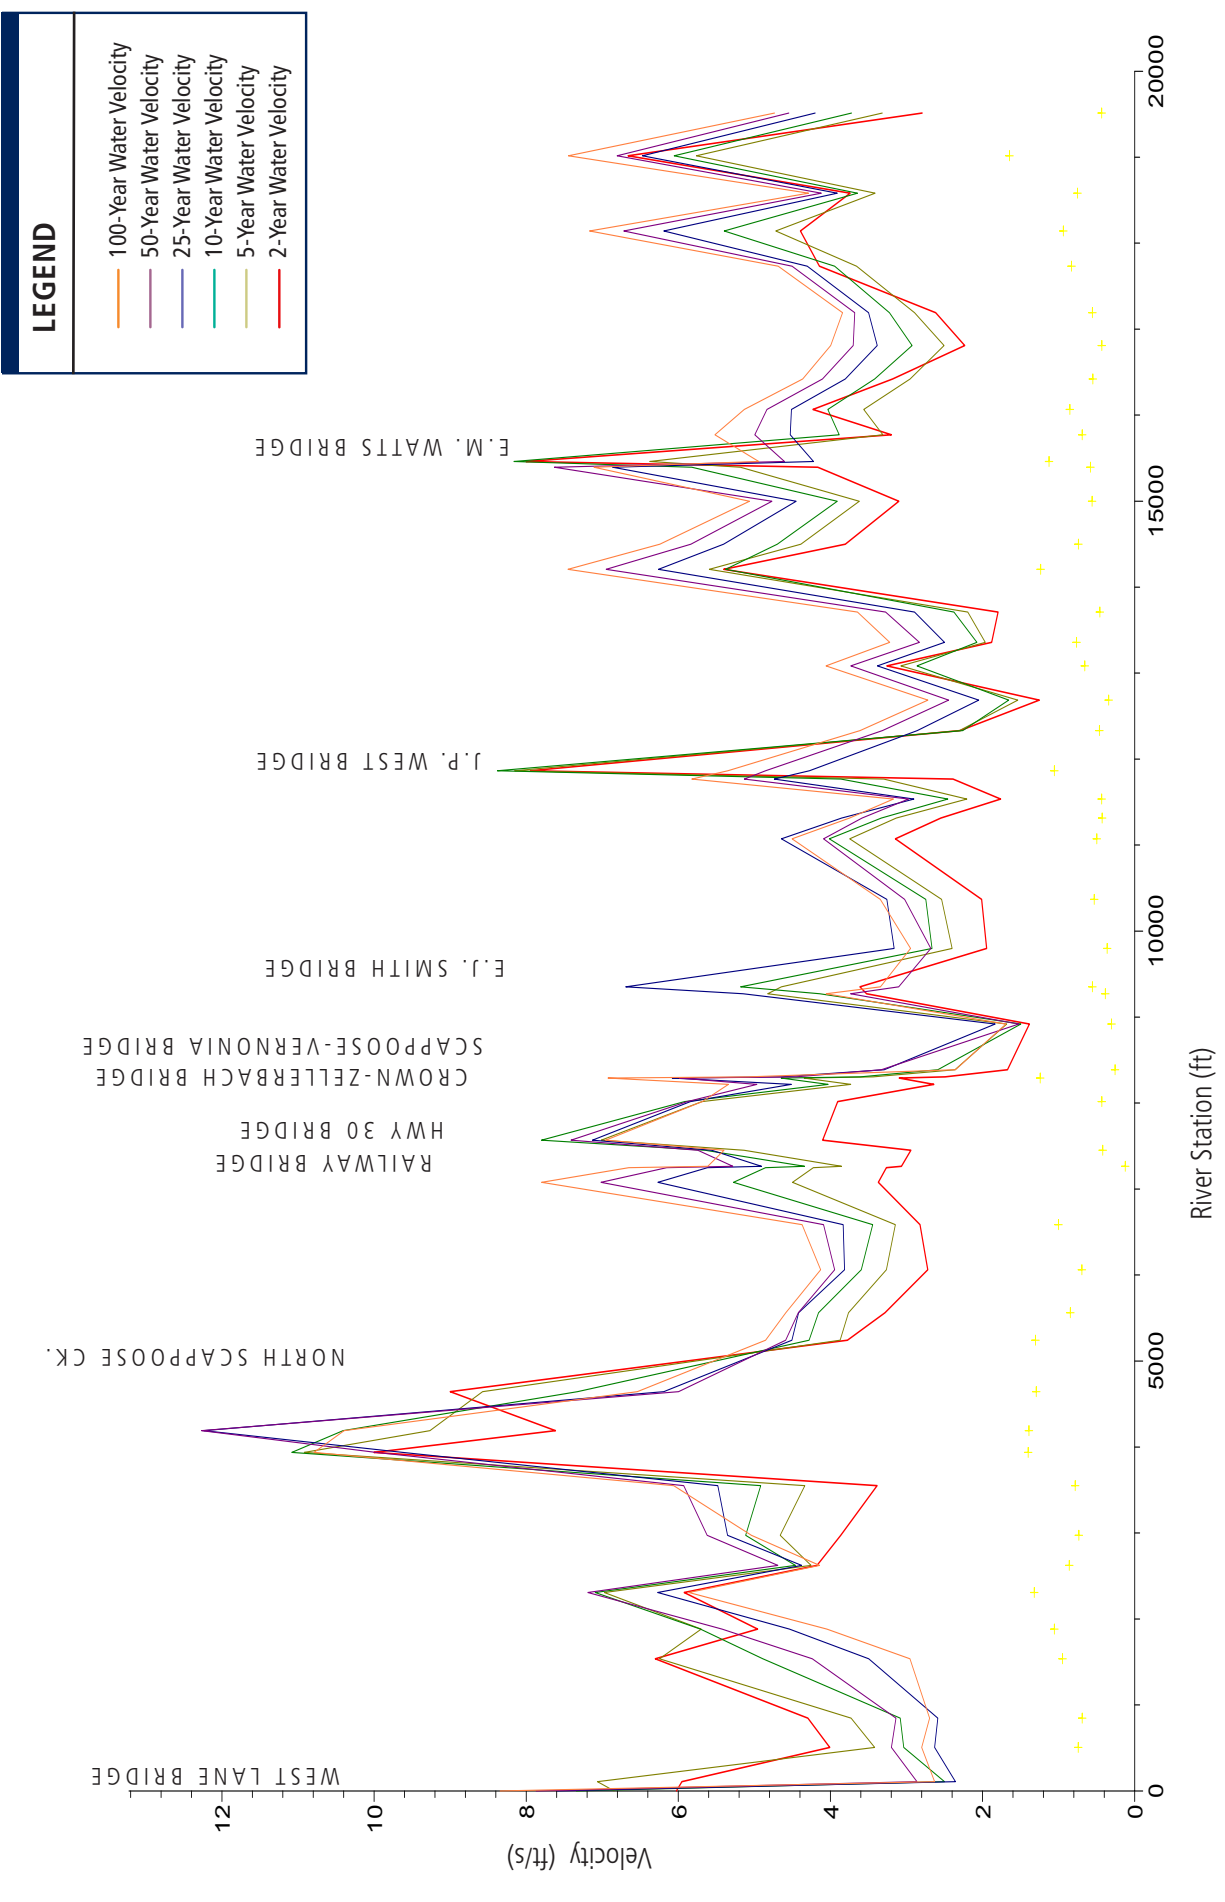
FIGURE 18: Modeled velocity profiles for South Scappoose Creek for the portion of the project area covered by the LIDAR data. Velocity peaks tend to occur in the vicinity of the bridges due to floodplain constriction and the grade breaks associated with headcutting which has been arrested at the bridges with placement of large rock.
