FINAL REPORT

South Scappoose Creek Restoration Plan

prepared for Scappoose Bay Watershed Council

MARCH 2009

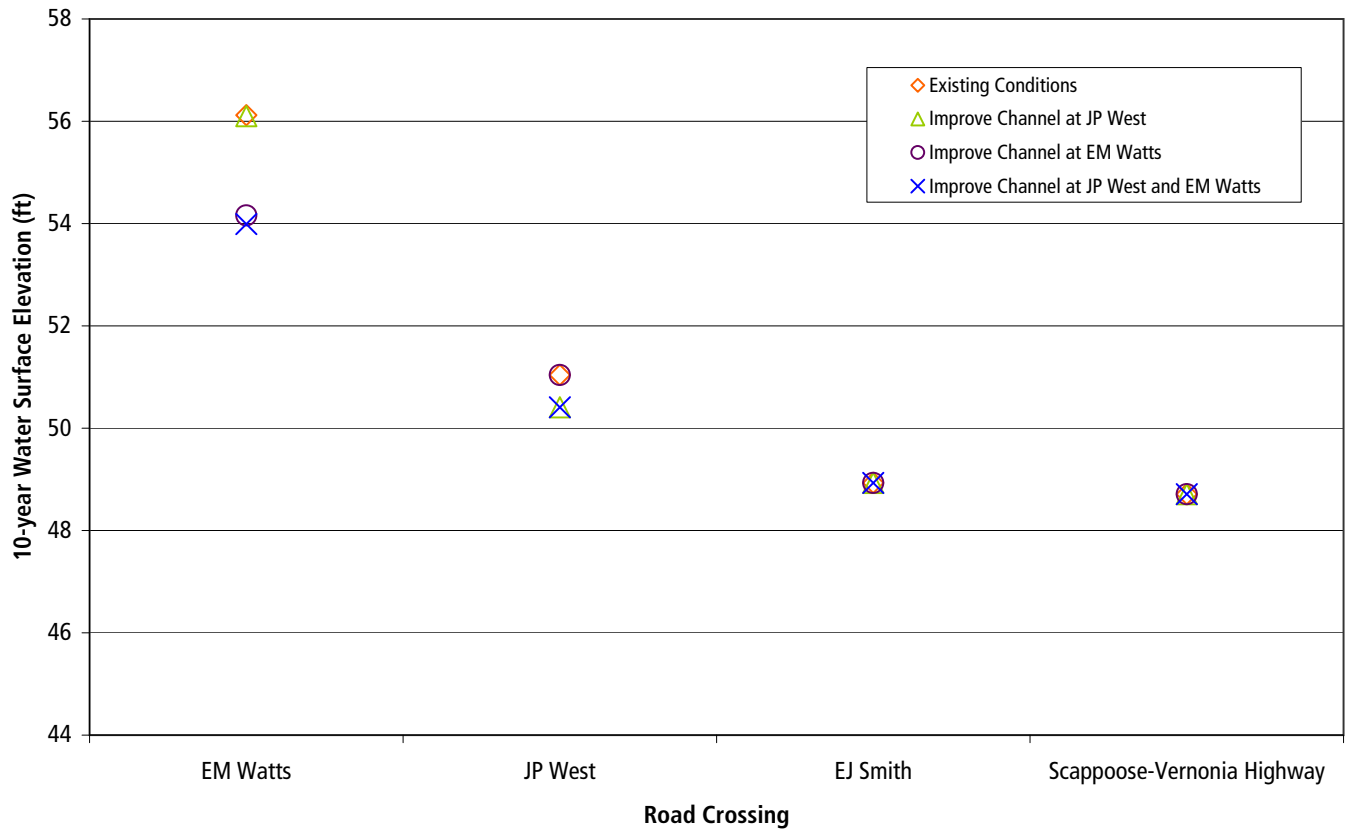
FIGURE 20: Summary of the hydraulic modeling results describing potential reductions in water surface elevations at several of the road crossings in the City of Scappoose reach of South Scappoose Creek resulting from modifications to the channel geometry upstream of the bridges to improve conveyance. The preliminary results suggest that improvements could be made at E.M. Watts and J.P West as a result of changes in the geometry of the channel, rather than direct modification or replacement of the bridges.
