FINAL REPORT

South Scappoose Creek Restoration Plan

prepared for Scappoose Bay Watershed Council

MARCH 2009

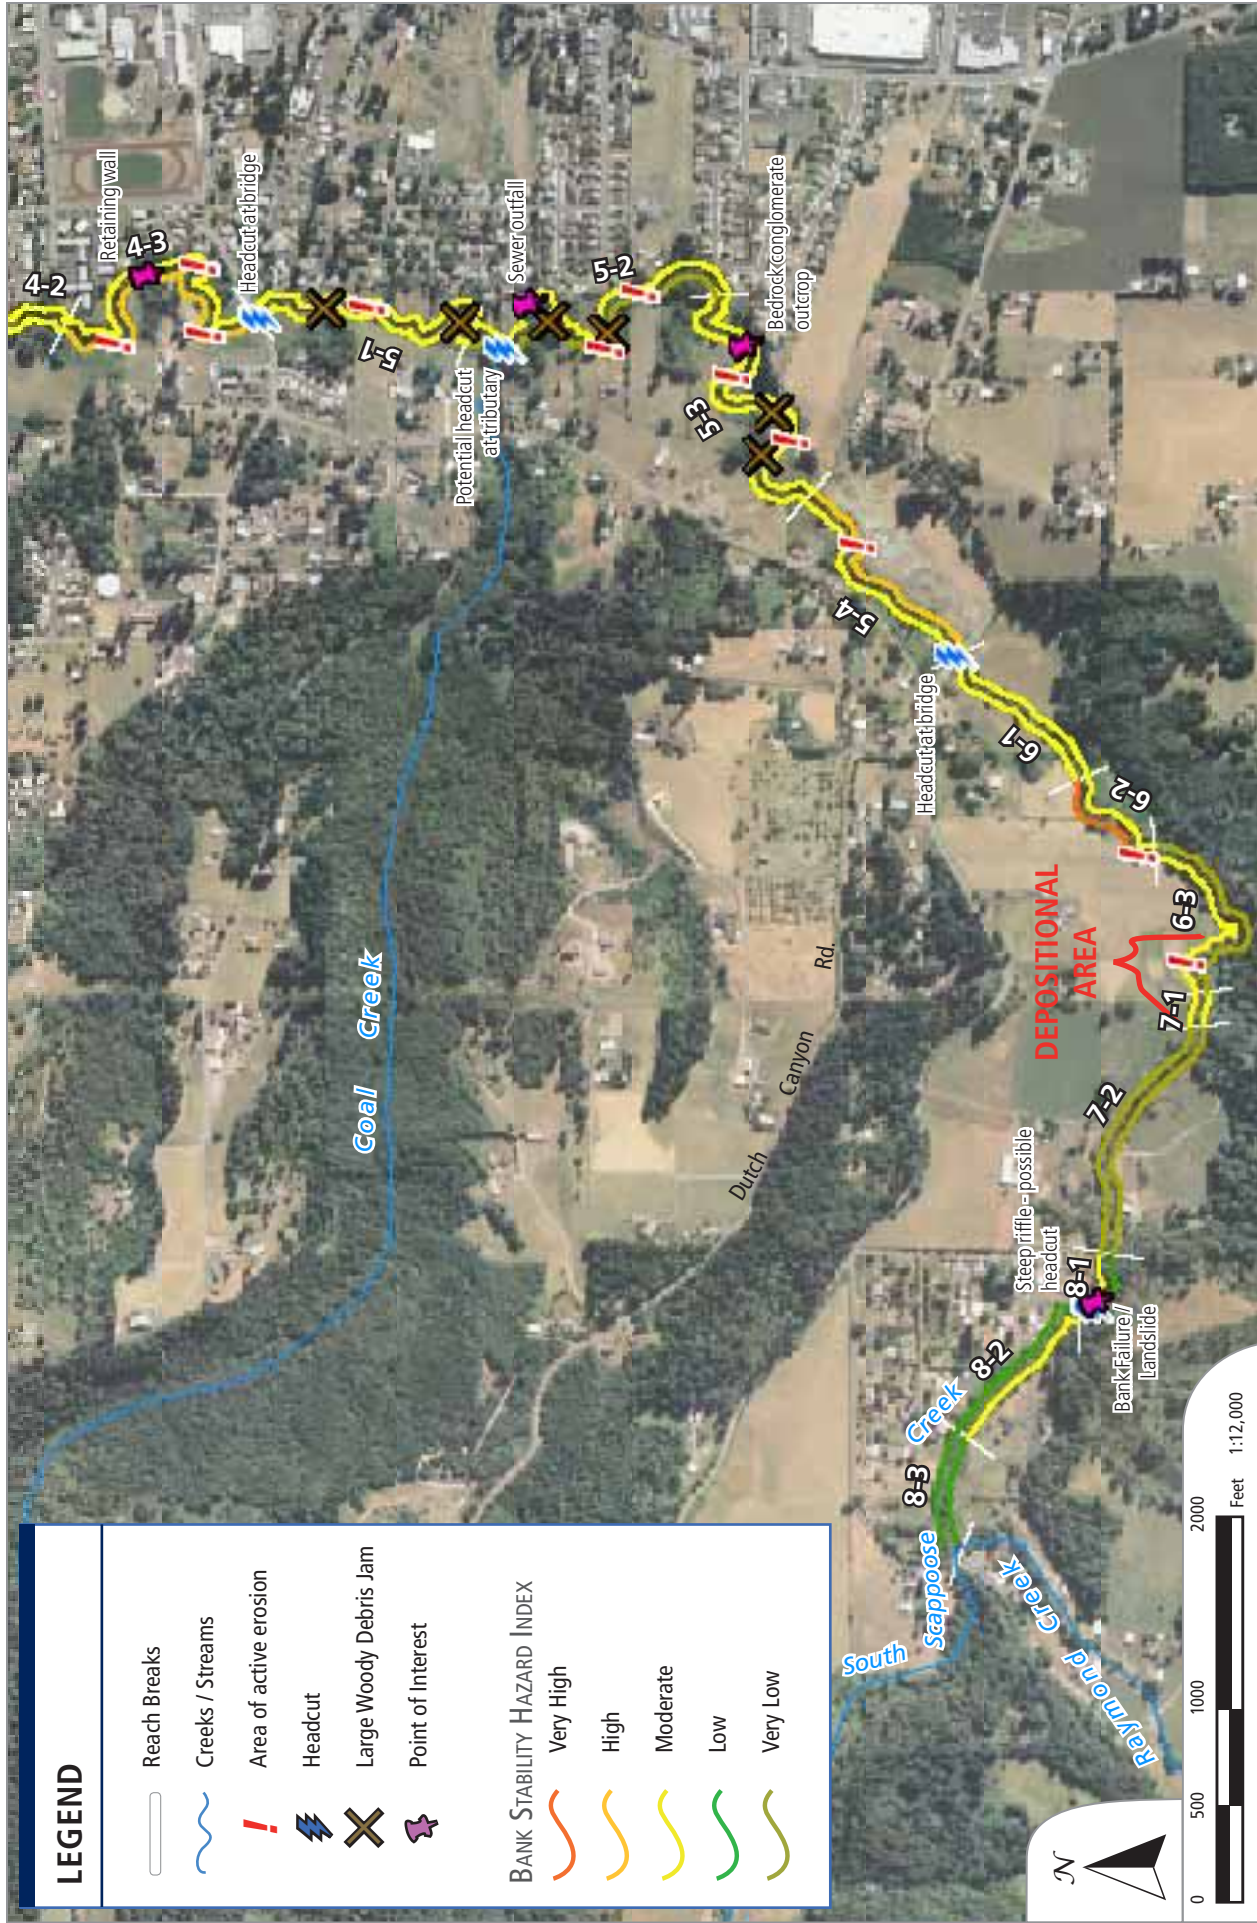
ES-3: A bank and channel stability survey was conducted on South Scappoose Creek through the project area. The selected study approach, based on Rosgen (1996), produced a Bank Erosion Hazard Index (BEHI) for each bank along with site specific bank and bed stability observations.

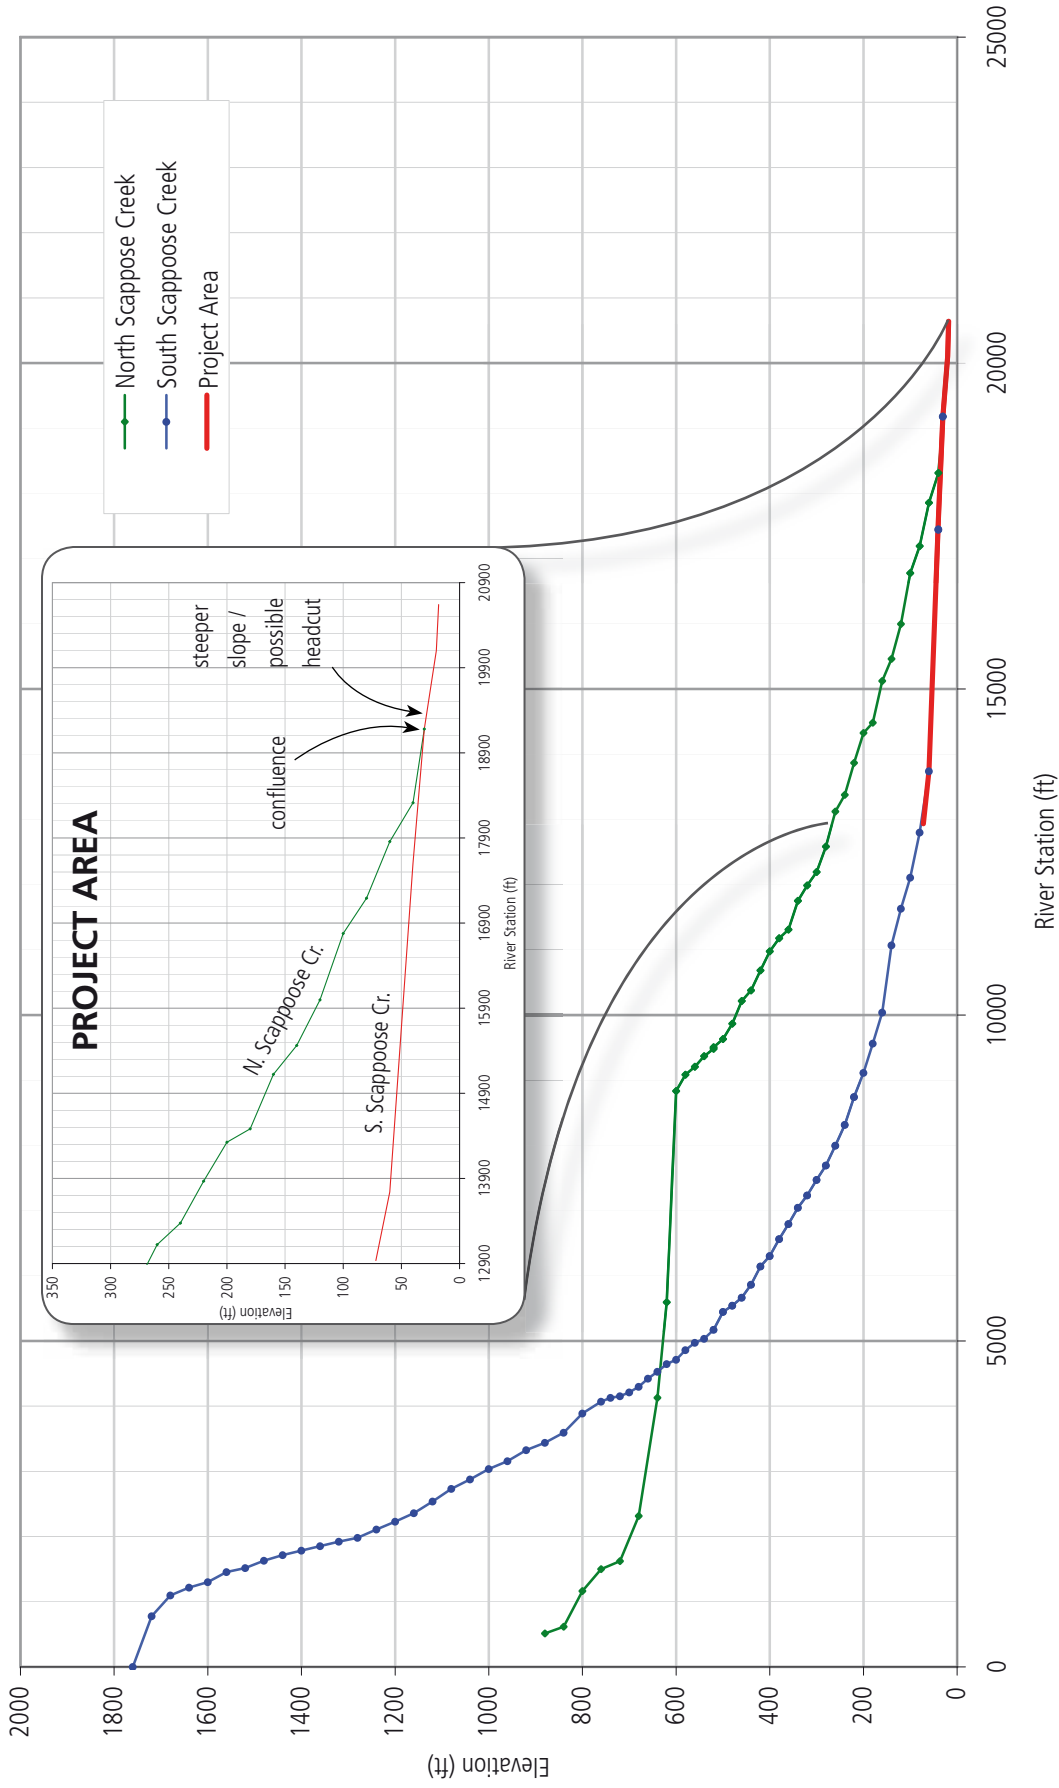
FIGURE 8: Longitudinal profiles for South Scappoose and North Scappoose Creeks derived from USGS 1:24,000 scale Digital Line Graphs (DLG's). Note the graded form of South Scappoose compared to North Scappoose which reflects the differences in the surficial geology along the primary channel.

Evidence of historic headcutting was observed during the field assessments and through an analysis of the longitudinal profile of the channel (Figure 8). Regionally, an apparent zone of channel instability was identified in the longitudinal profile in the area just downstream of the confluence of South and North Scappoose Creeks. On North Scappoose Creek, the last 500 feet of channel, before it conflues with South Scappoose Creek, is oversteeped, creating a grade difference of approximately six feet over several coarse riffles. The mouth of North Scappoose Creek can be characterized as depositional. Coarse bed load from the higher gradient lower reaches of North Scappoose Creek are delivered into a “fan-like” feature at the confluence with South Scappoose. This coarse fan, consisting primarily of rounded cobble, creates resistance to the incision that is evident on South Scappoose Creek. The result has been local incision and steepening of the North Scappoose fan, abandonment of several secondary floodplain channels, and an inability of the observed headcut to migrate further upstream on North Scappoose Creek. Below the confluence, a series of steep riffle may represent an area of future planform instability, whereby the riffles, or distributed headcuts, would migrate upstream, lowering the bed and steepening banks. This area should be monitored in the future to determine if headcutting is occurring, although the coarseness of the bed material through this reach may provide resistance to future headcutting.

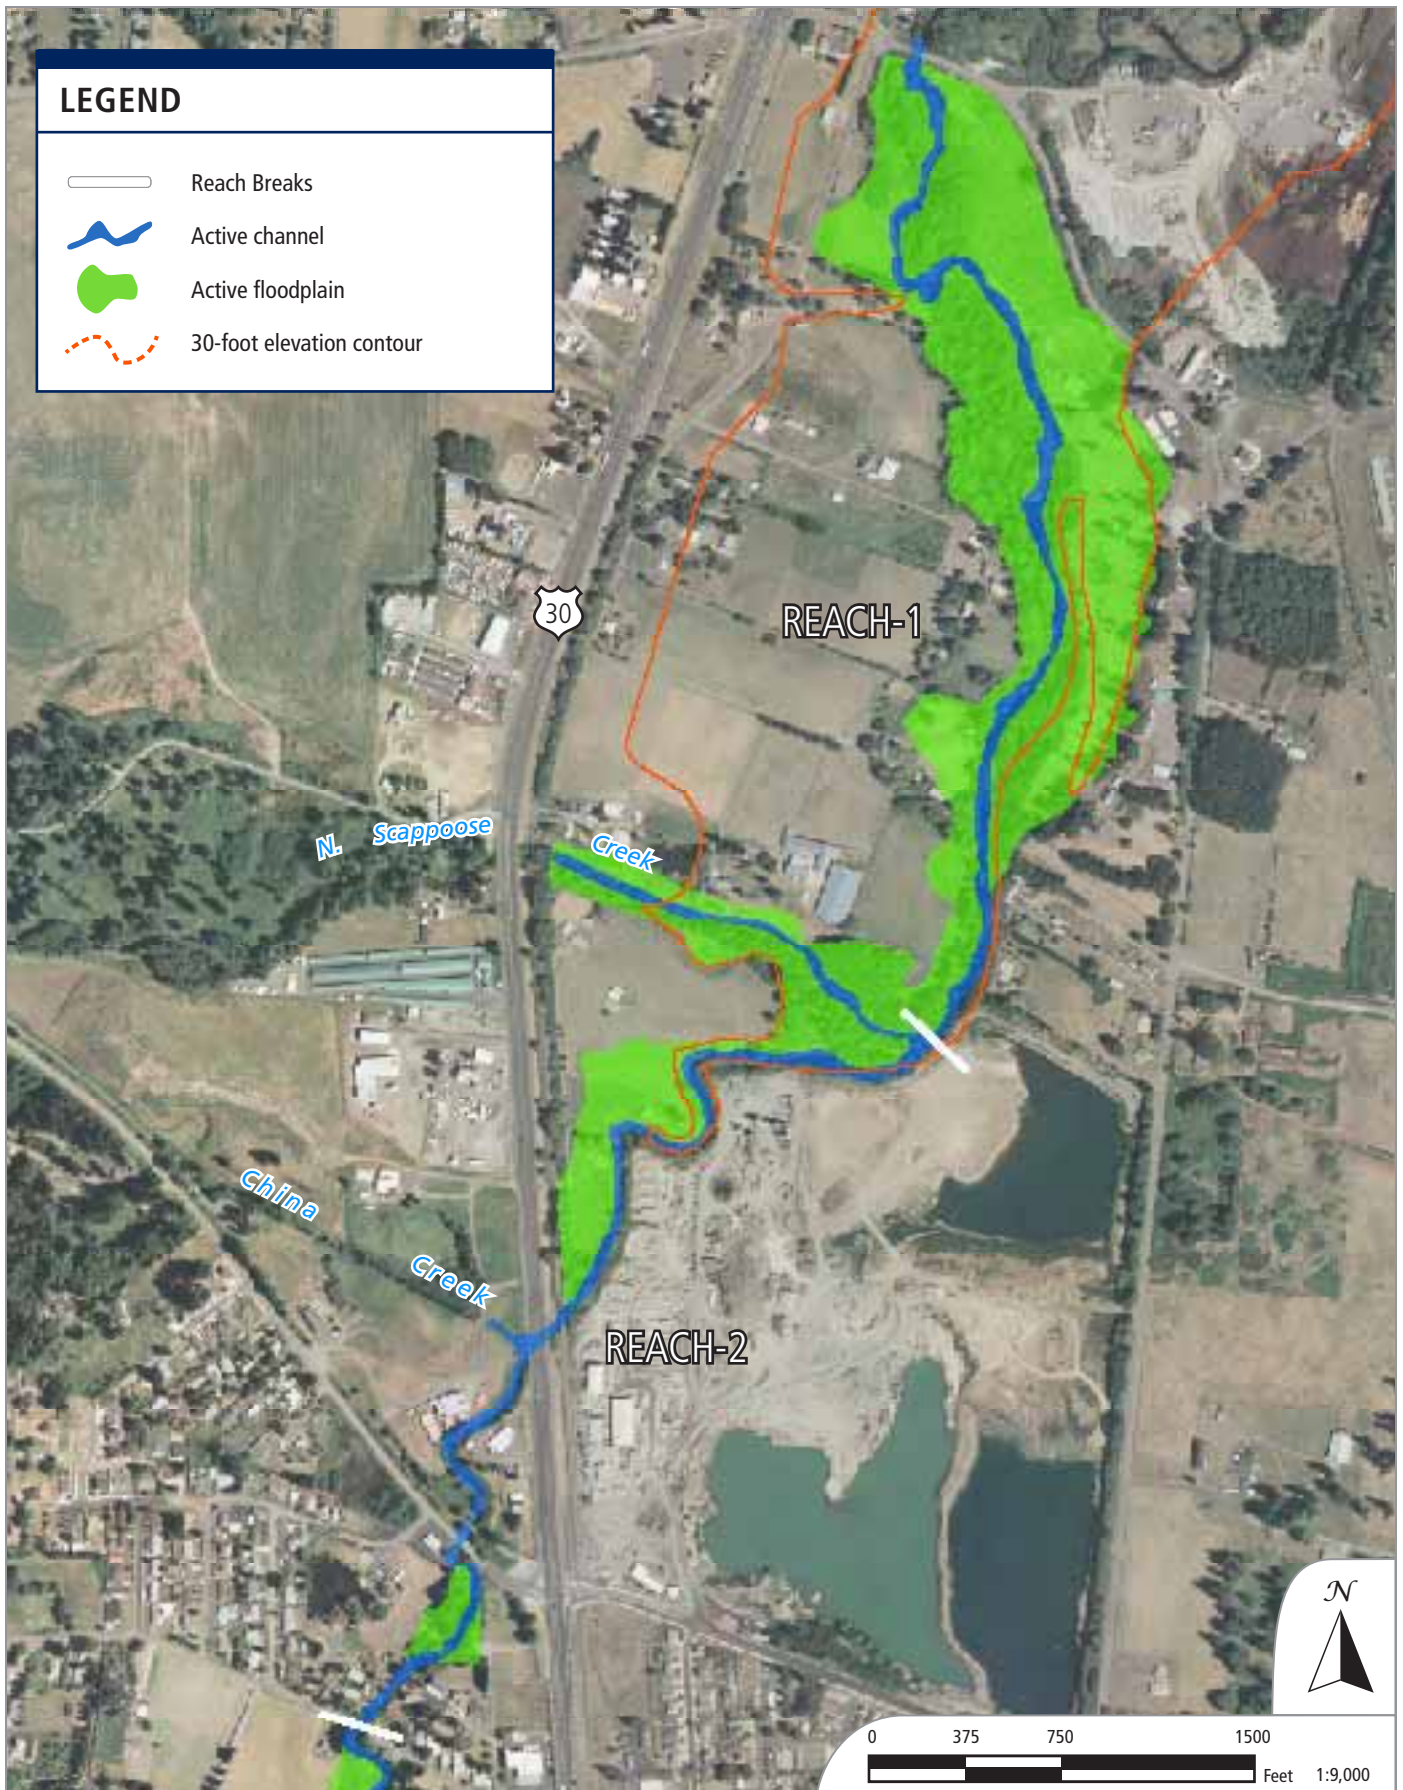
FIGURE 14: Geomorphic map of project area covered by existing LIDAR data. Mapped features include the primary active channel and adjacent undeveloped areas that are, or have the potential to provide function floodplain and riparian habitat. Also shown is the 30-foot contour which depicts the historic extent of Columbia River flooding.

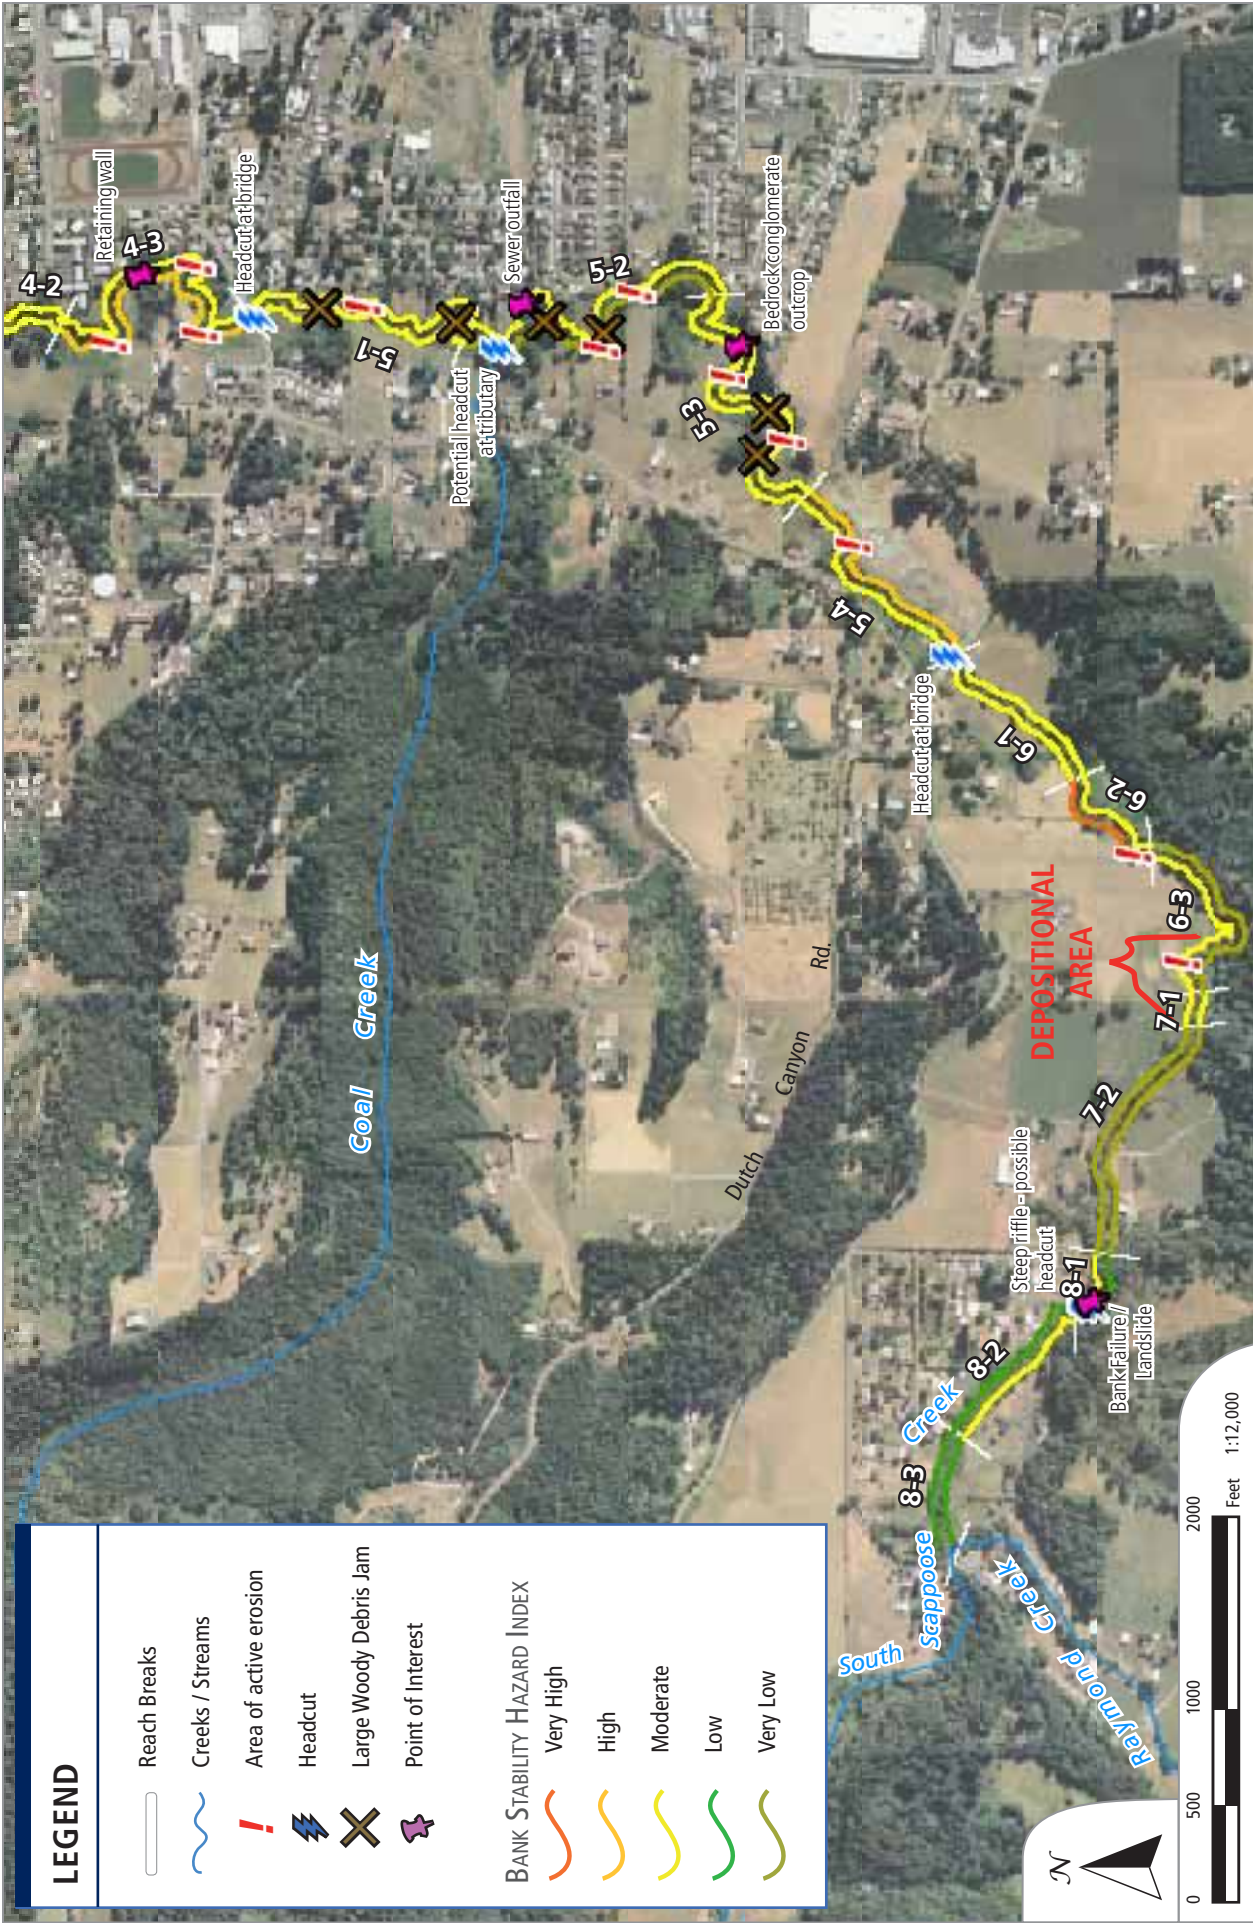
FIGURE 16: A bank and channel stability survey was conducted on South Scappoose Creek through the project area. The selected study approach, based on Rosgen (1996), produced a Bank Erosion Hazard Index (BEHI) for each bank along with site specific bank and bed stability observations. 39

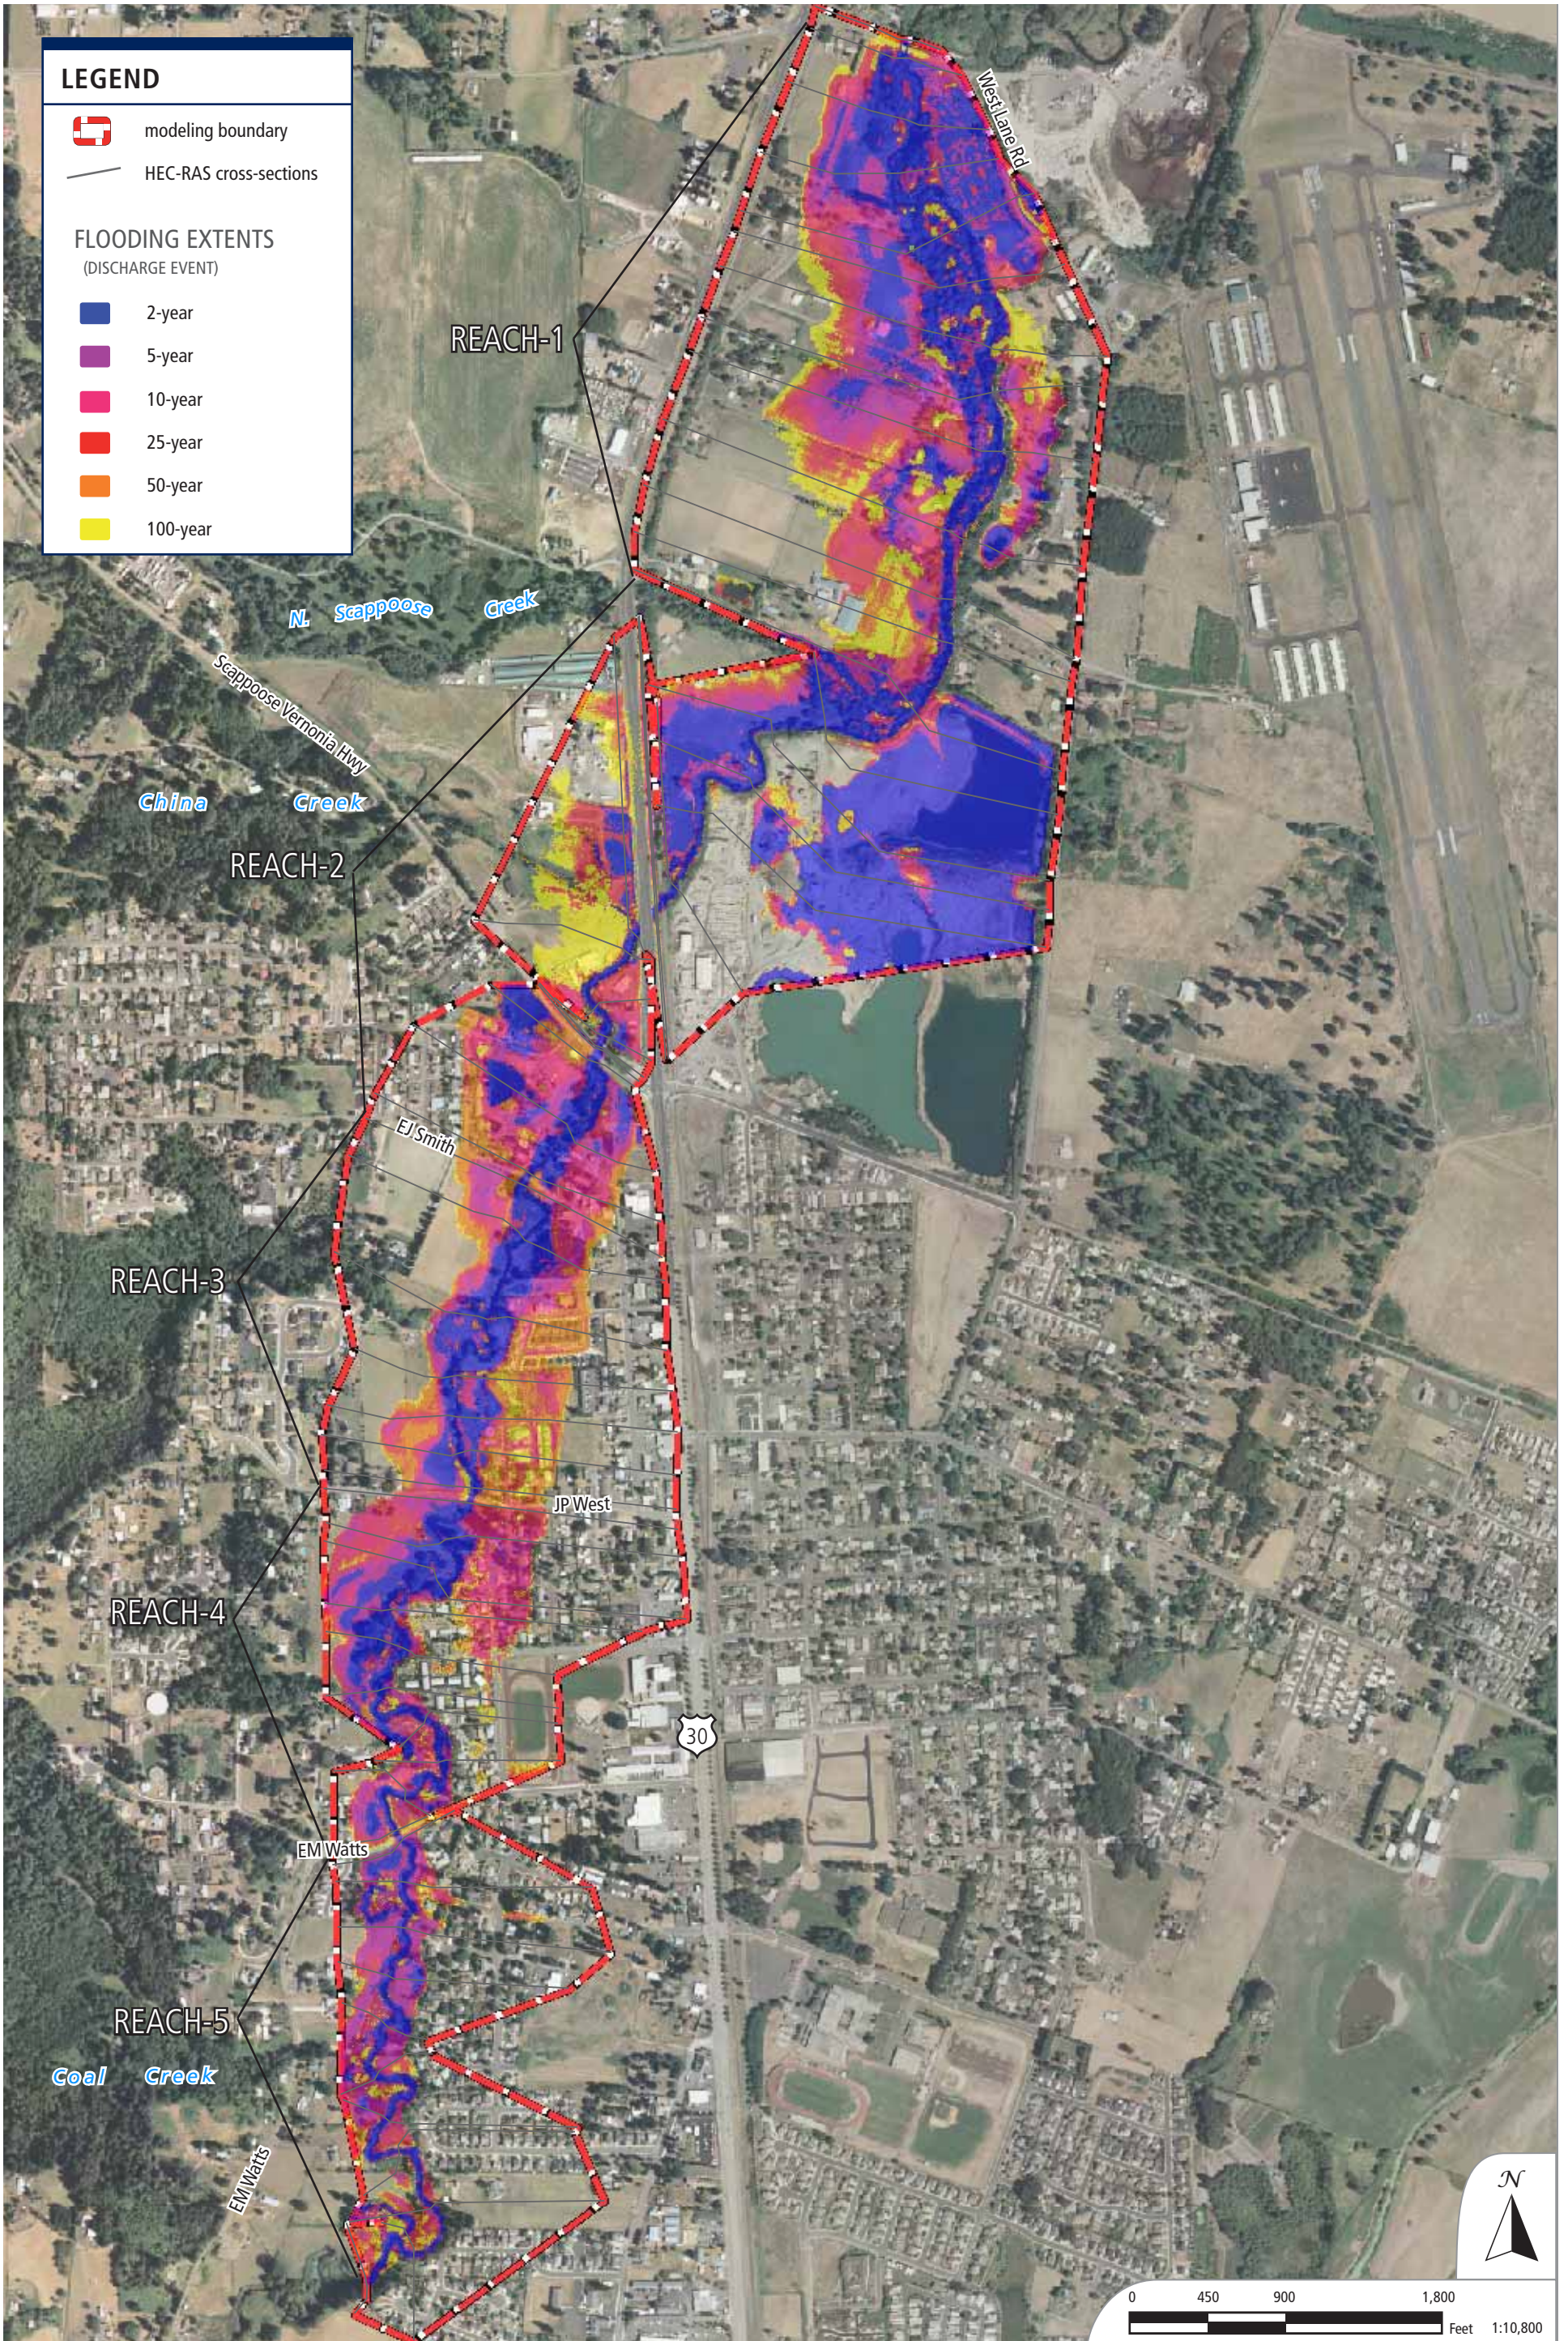
The results of the hydraulic analysis are presented in Figures 17, 18, and 19. Figure 17 presents a water surface profile for the 2-year, 5-year, 10-year 25-year, 50-year, and 100-year flood events. Frequent flooding (e.g. – 5-year and greater) inundates the adjacent valley floor at the lower end of the project area and at the upstream end of each of the main bridges. In most cases, the bridges are inundated and overtopped in the 25-year, 50-year, and 100-year events. The exception is the E.J. Smith Bridge which appears to be inundated more frequently. The velocity profiles suggest similar hydraulic dynamics (Figure 18) at the existing bridges. Prior to the bridges overtopping, water is forced through the bridges in response to an increase in head on the upstream side of the bridge. The increase in head results in higher velocities through the bridge sections which is likely exacerbated by the steeper grade at the bridge associated with the arrested headcuts. Flow velocities are relatively low upstream of the bridges, where a backwater is created, and high immediately downstream of the bridges. High flow velocities at the downstream side of bridges can exacerbate bank erosion, as was observed downstream of the Raymond Creek Bridge.

FIGURE 19: Modeled extent of flooding on South Scappoose Creek for a range of peak flows. Modeling was conducted using a HEC-RAS model and was limited to areas adjacent to the existing channel and where LIDAR topographic data are available.
